MCWRA Innovative Water Technologies For California Workshop March 23, 2018

Improving Your Delivery System Resiliency: Hazard Evaluation and Mitigation of Canal and Tunnels

> Ron Skaggs, PE, GE Condor Earth

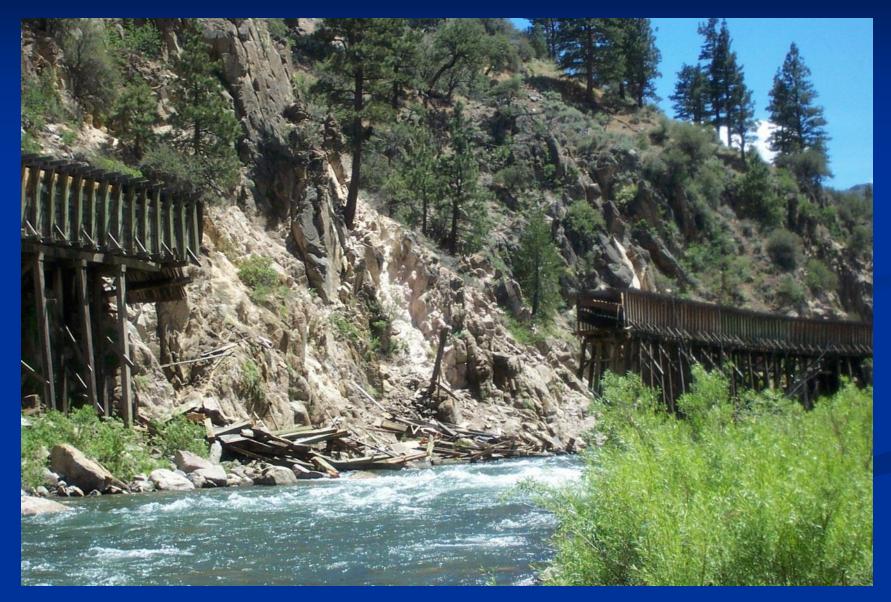
## 2003 Slide Event

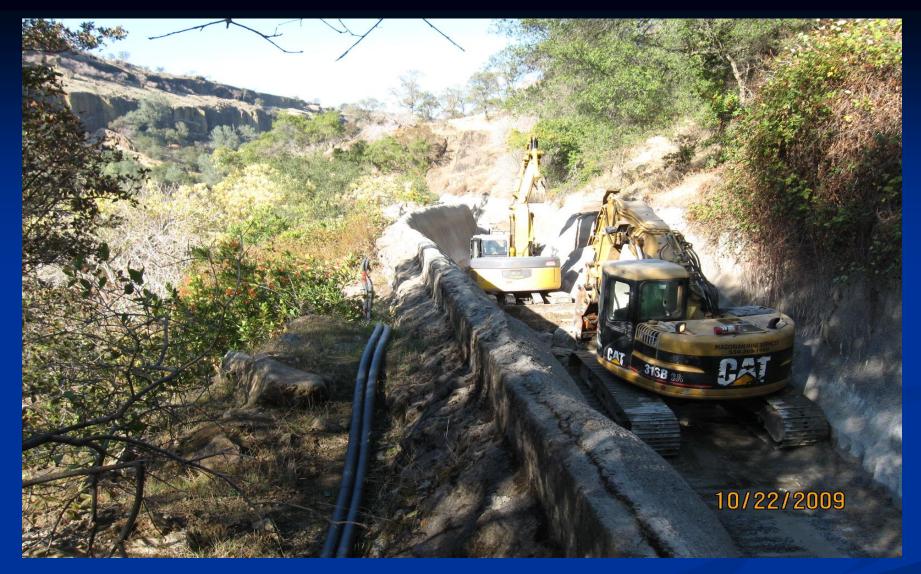
Segment 1: Canal Invert Demolition in Structural Rehab Area

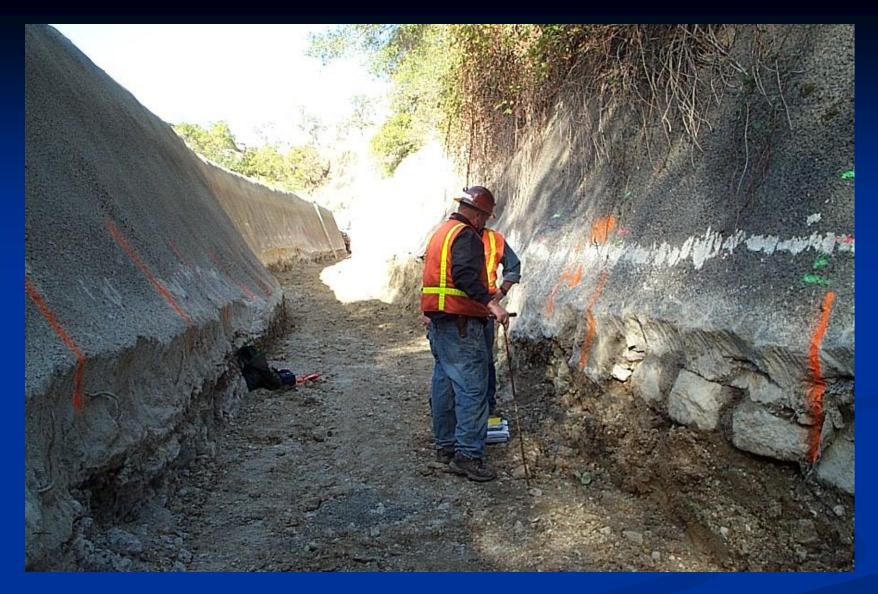
#### Segment 1: Observation of Canal Invert Demolition in Structural Rehab Area

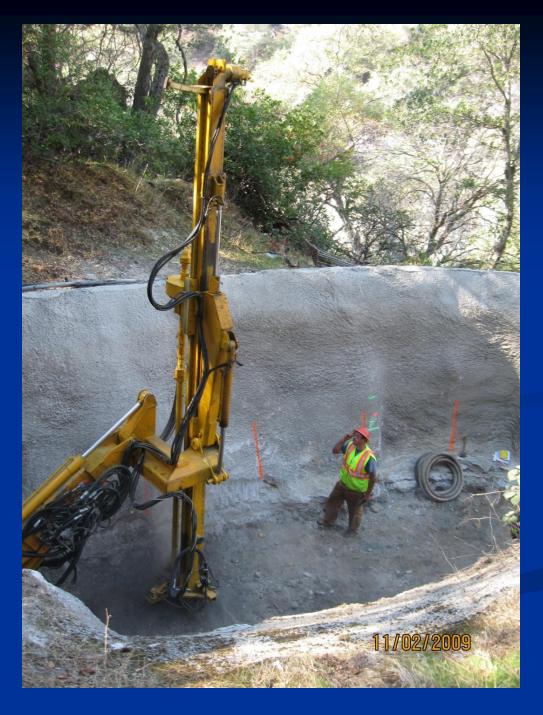
Segment 1: Micro-Pile Drilling Operation in Structural Rehab Area

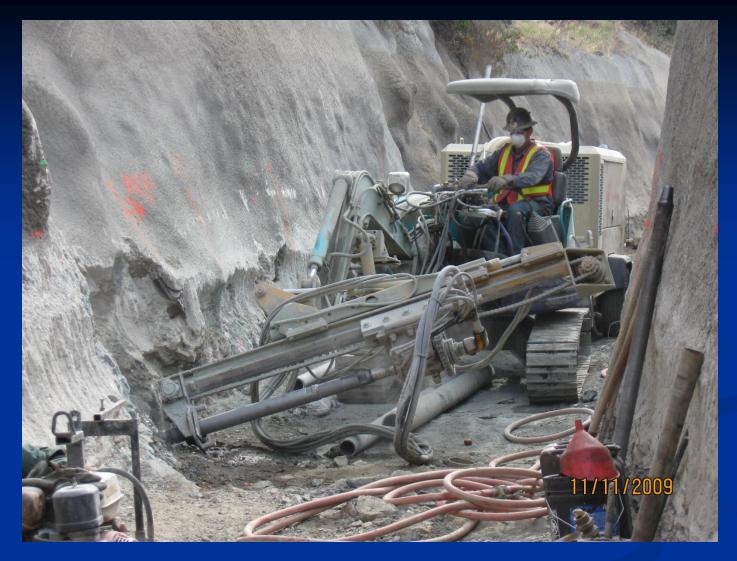
Segment 1: Canal Invert Lateral Tieback Installation in Structural Rehab Area Segment 1 Tie-back for Structural Slab

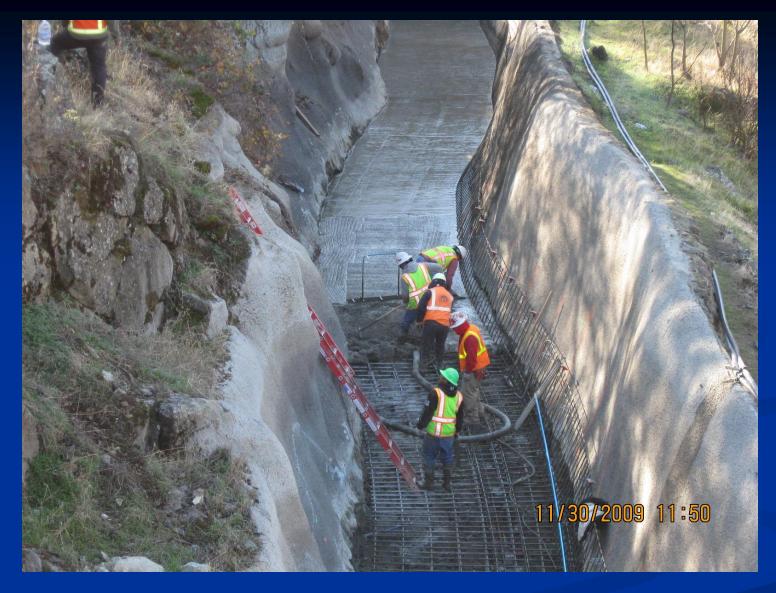
Segment 1: Structural Invert Concrete Placement After Micro-Pile Installation

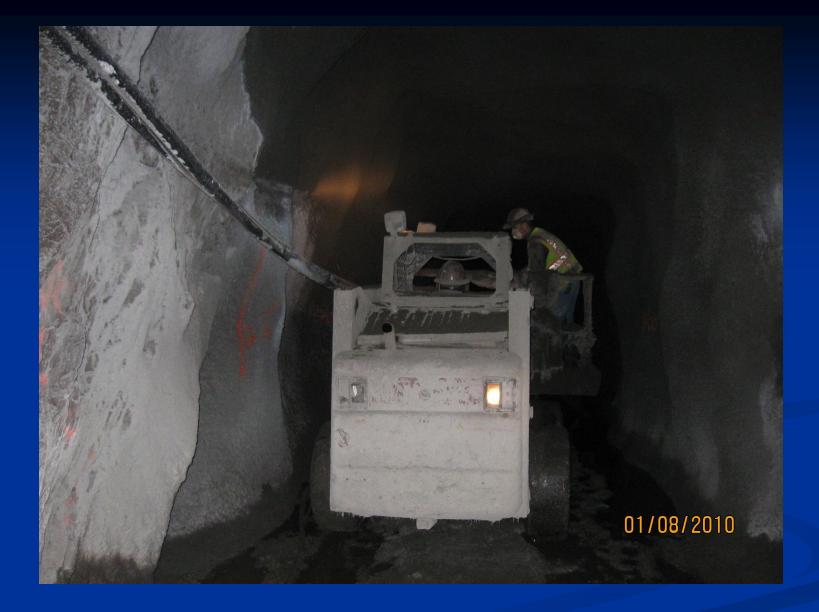
Segment 1: Tunnel 4 Repair in Thin Cover Section – Wire Mesh and Reinforcement Installation

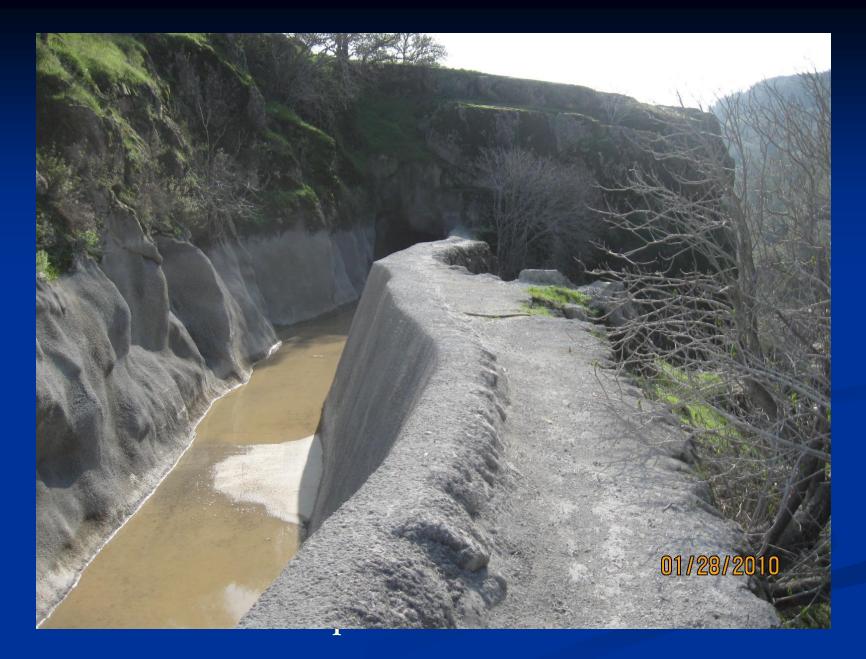
#### Segment 1: Shotcrete Repair

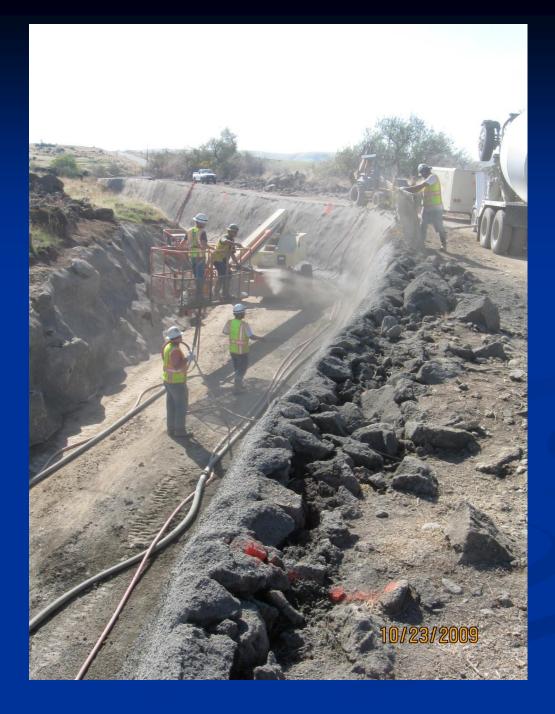
### **Starting Conditions**
