Erosion Control in Mountain Recreation Areas

Paul Wisheropp, P.E. CFM
Cardno ENTRIX

Camp Sacramento Erosion Control and Habitat Restoration Project

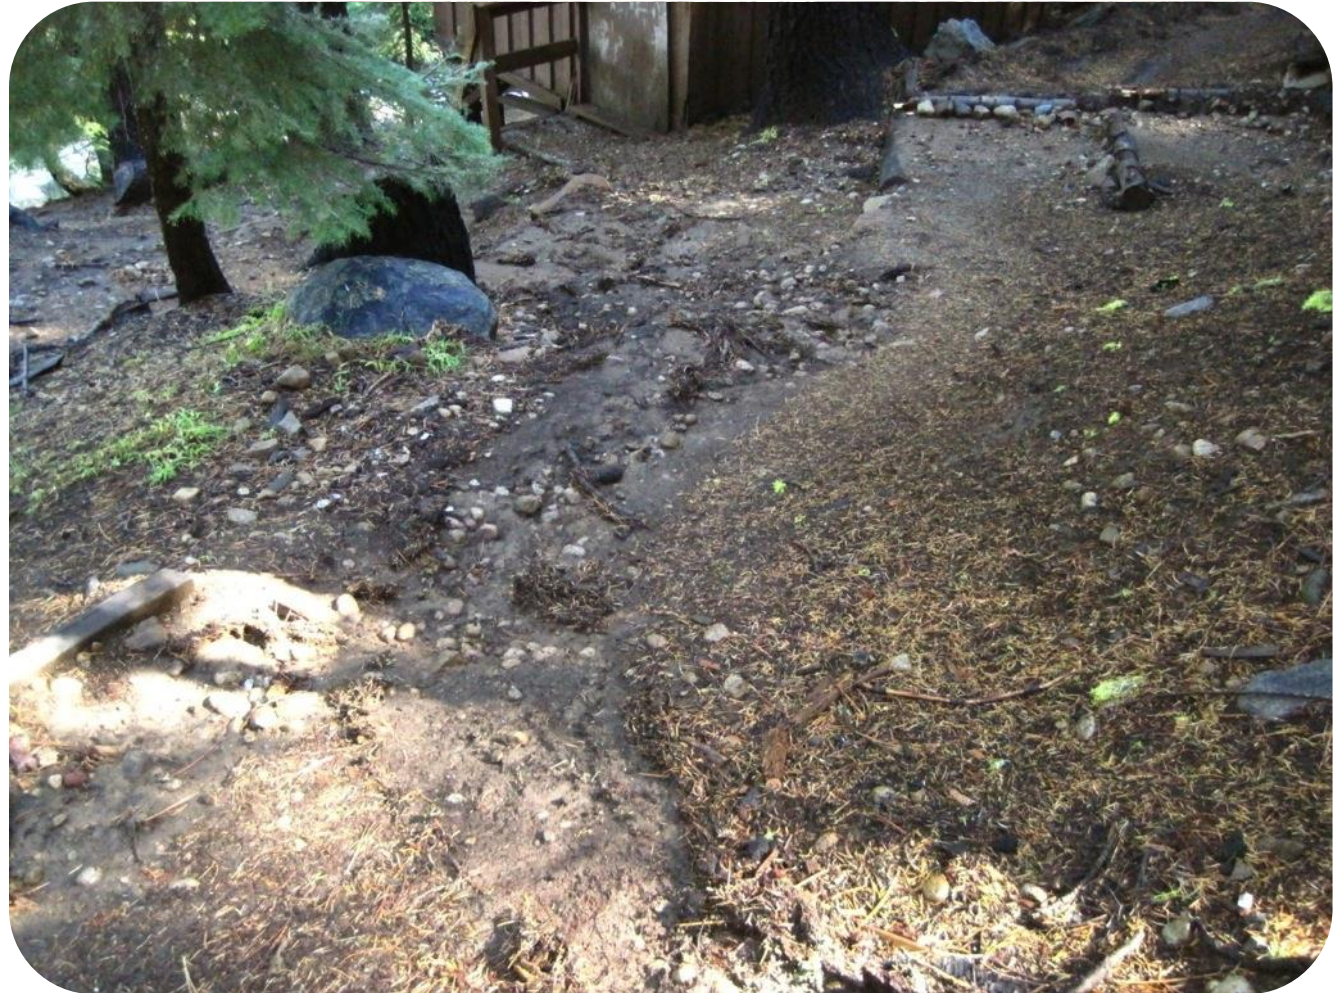
Erosion Problems

Hillslopes

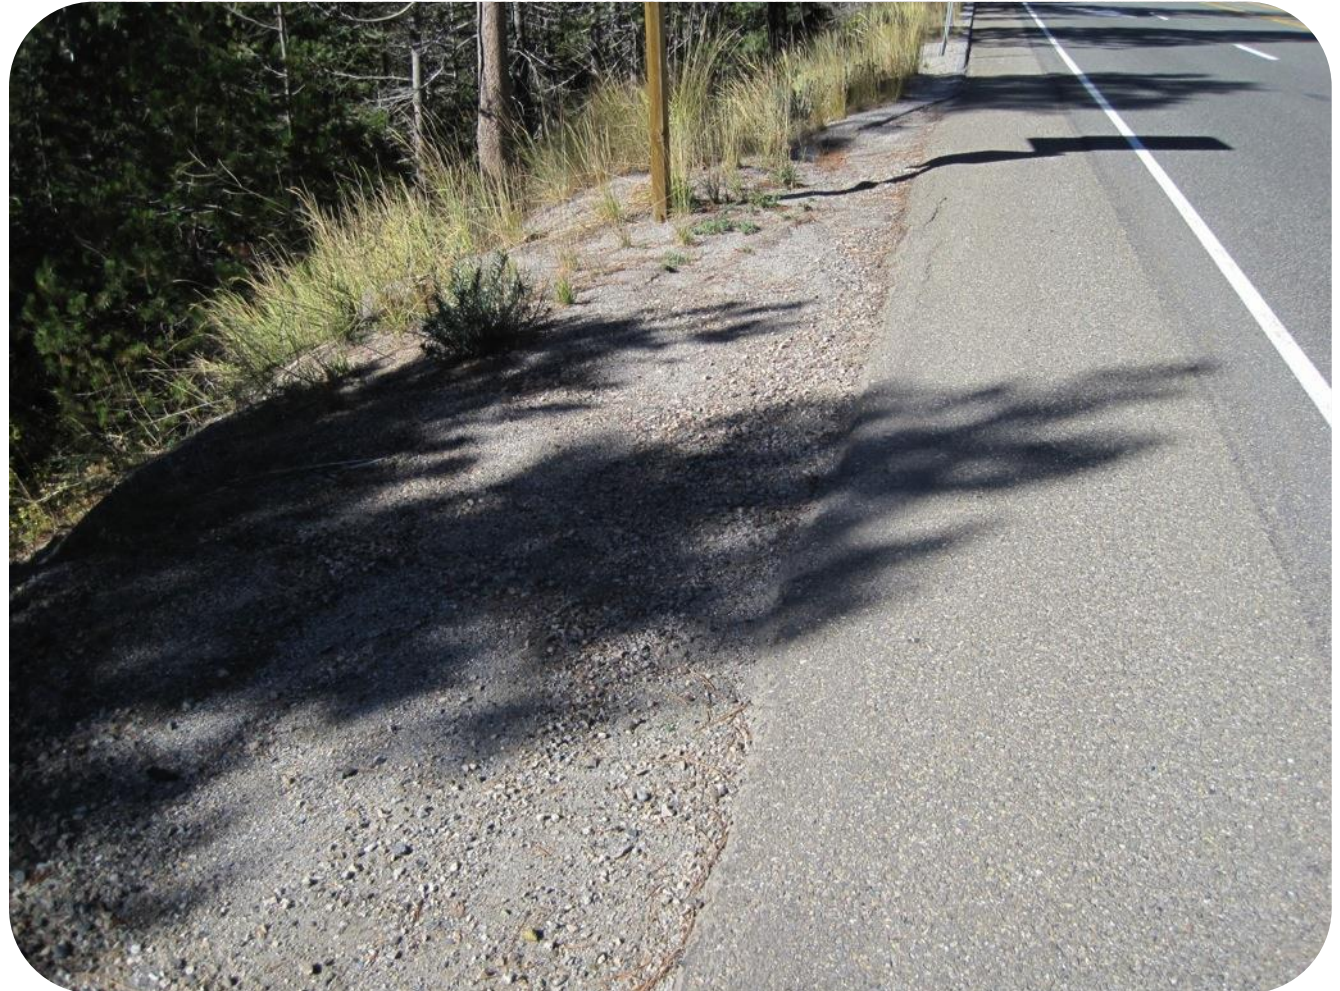
Erosion Problems

Highway
Shoulder

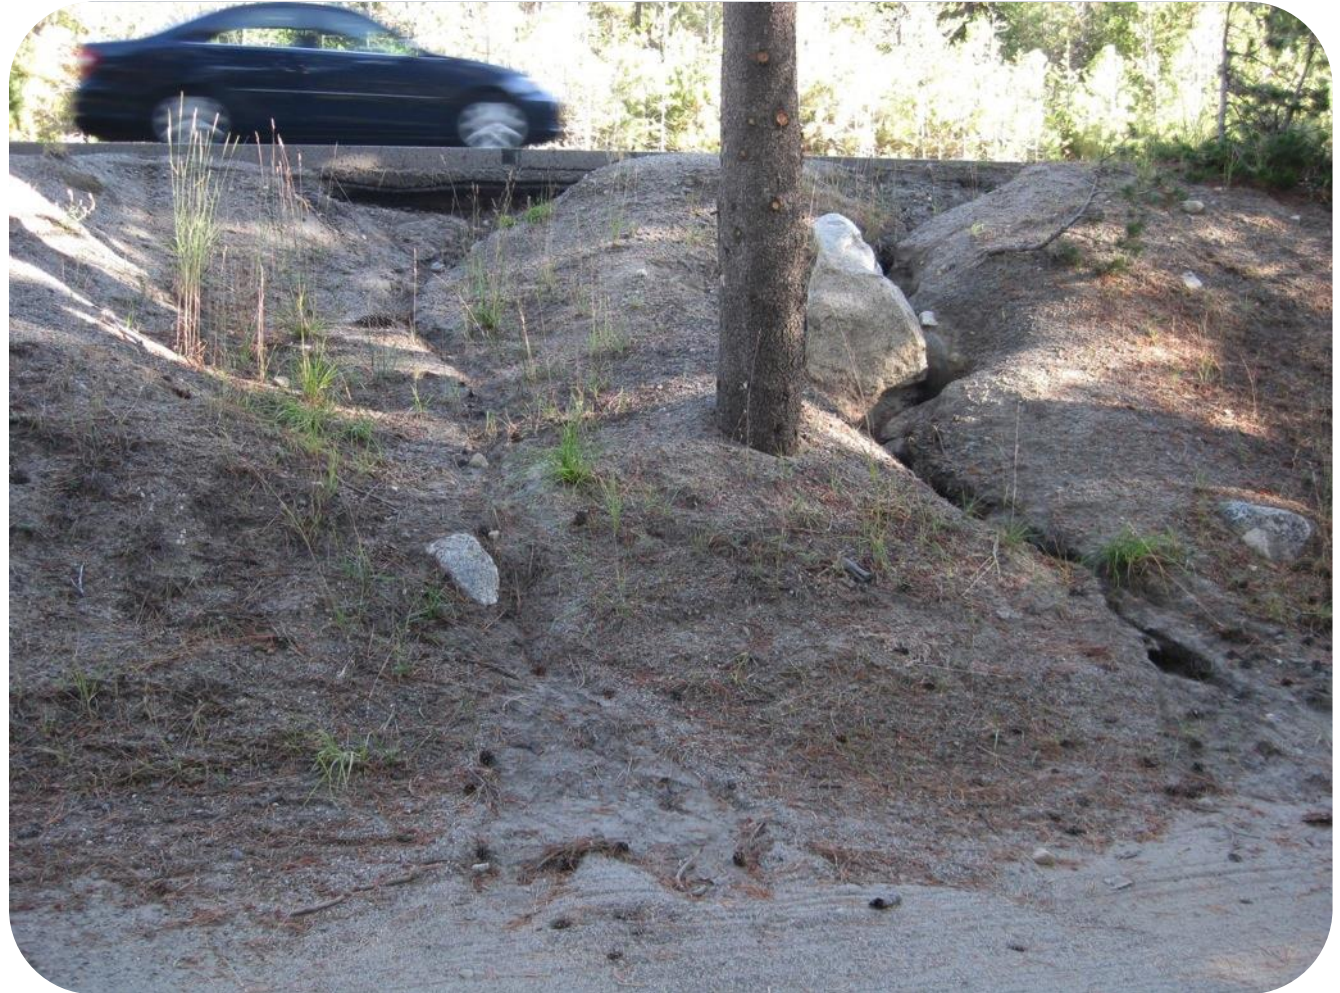
Erosion Problems

Highway Shoulder

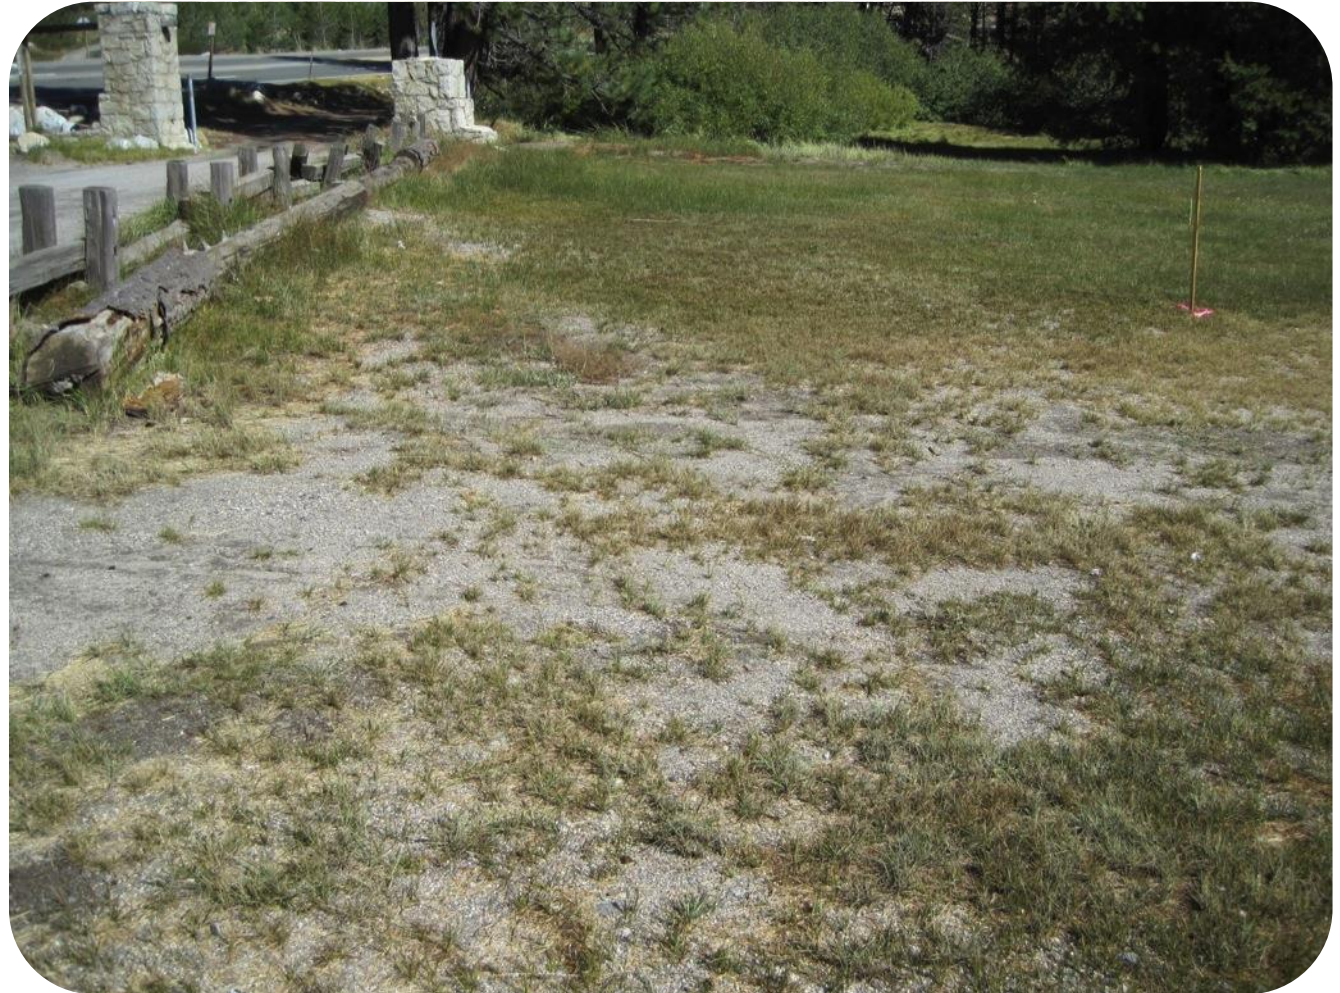
Erosion Problems

Highway Runoff

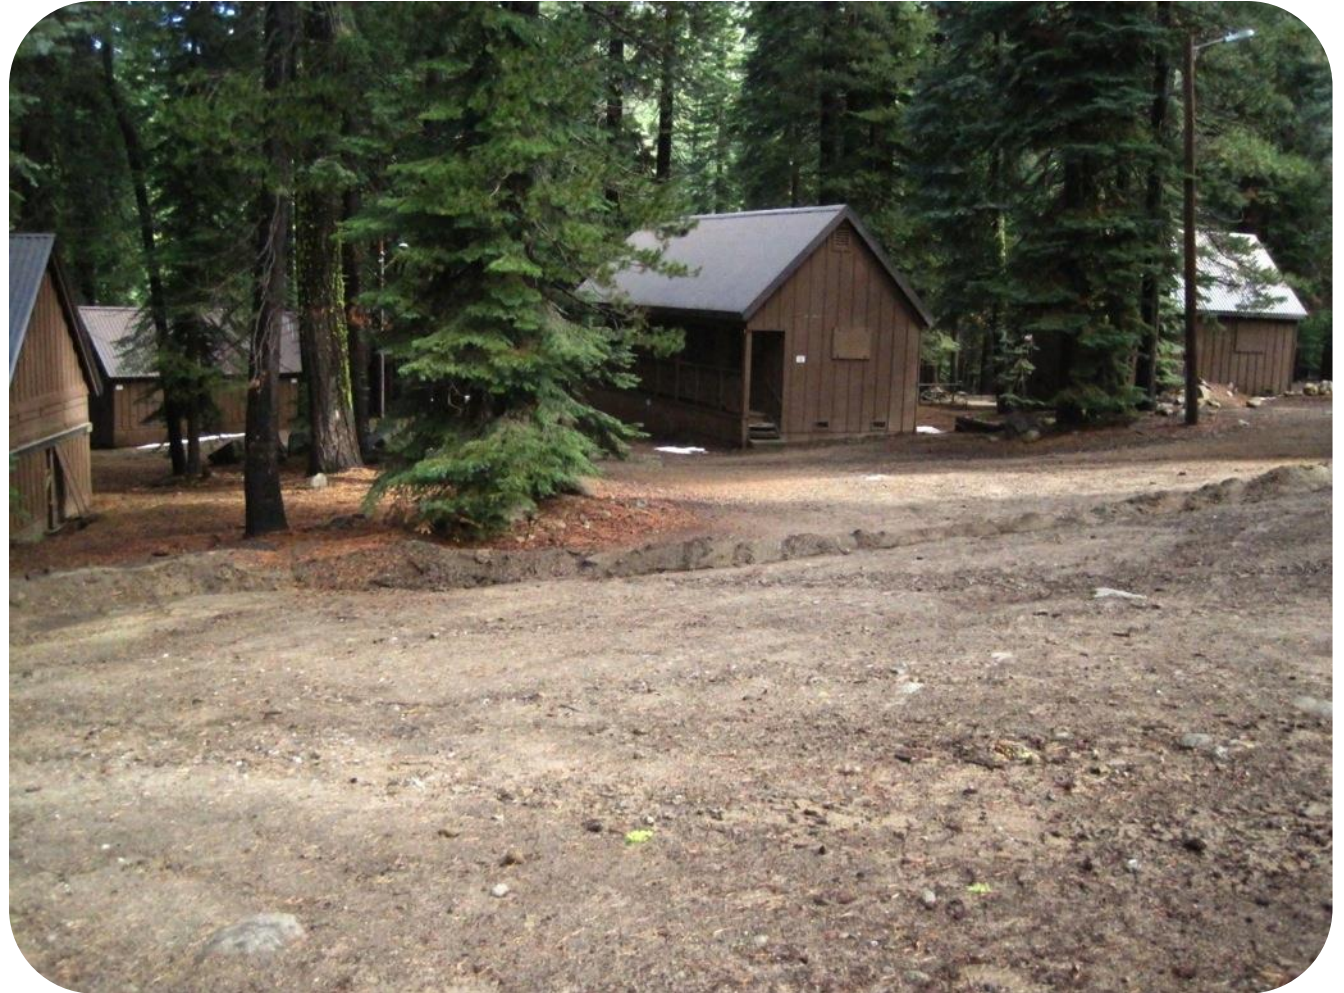
Erosion Problems

Parking

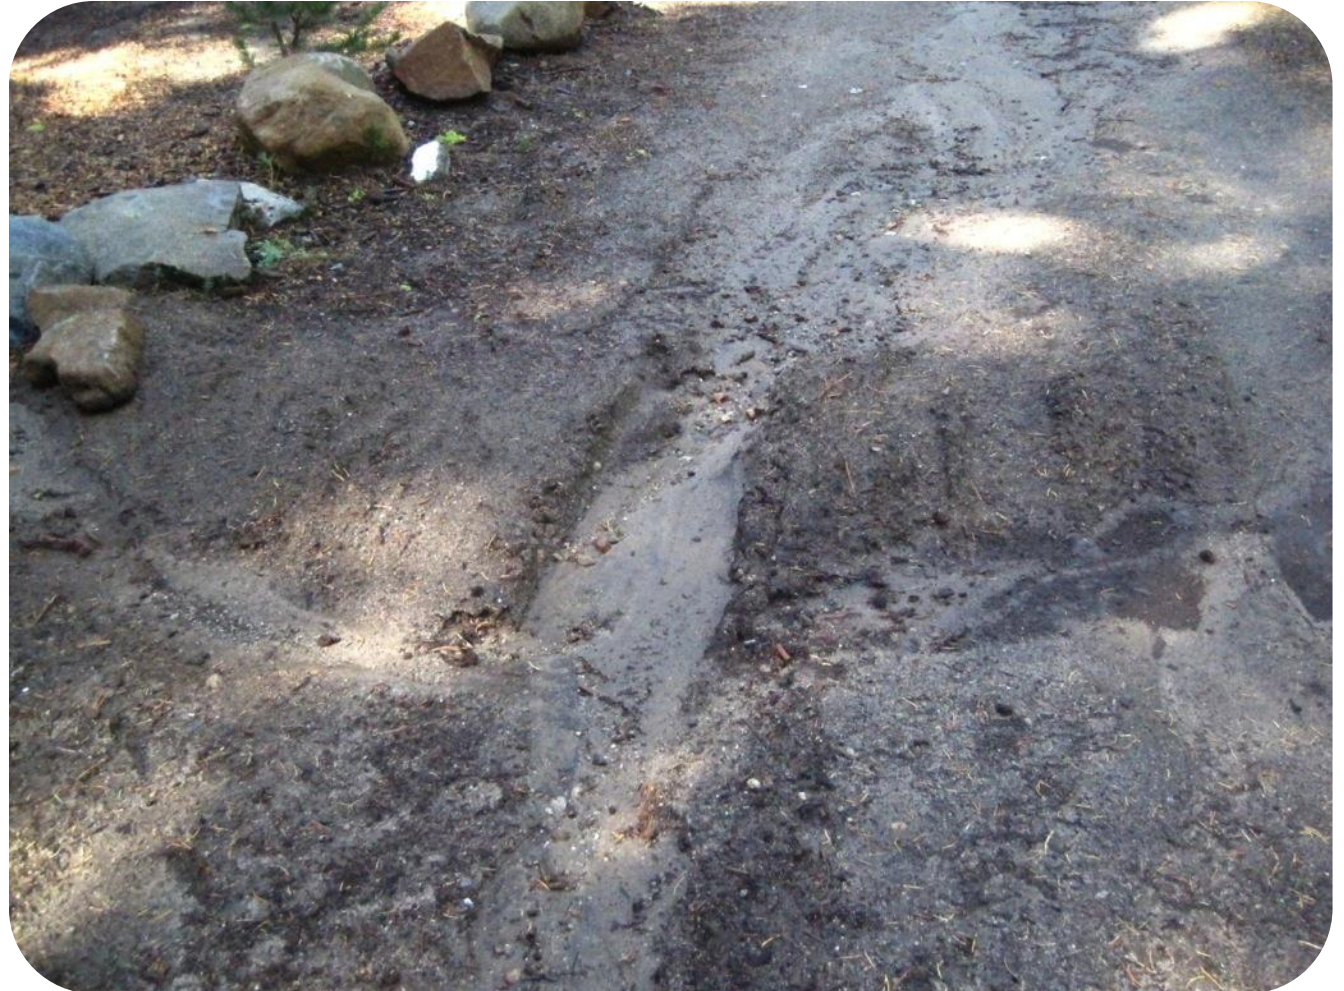
Erosion Problems

Roads

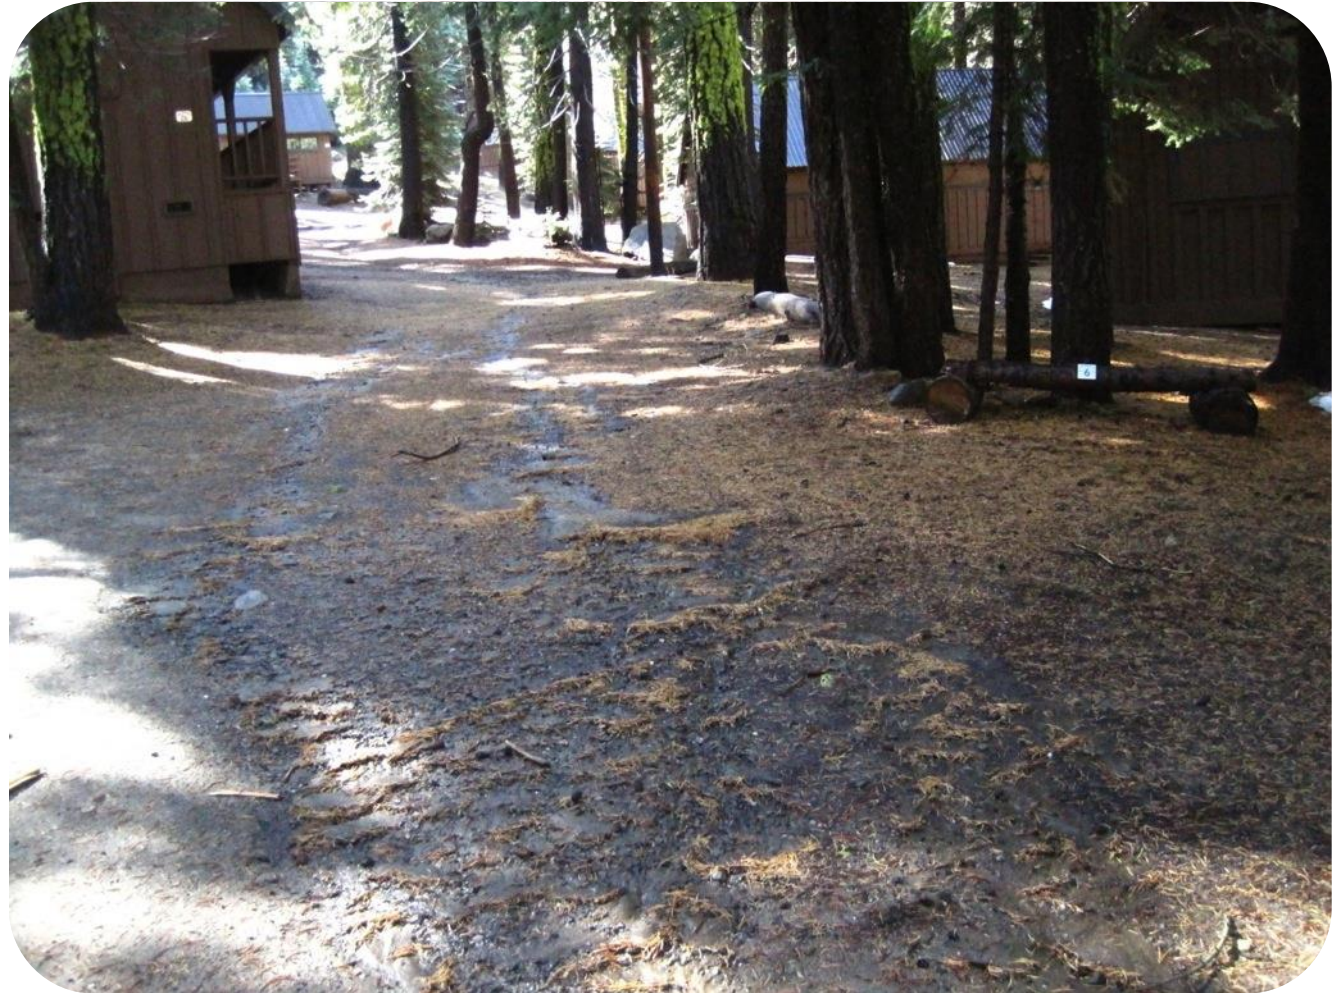
Erosion Problems

Roads

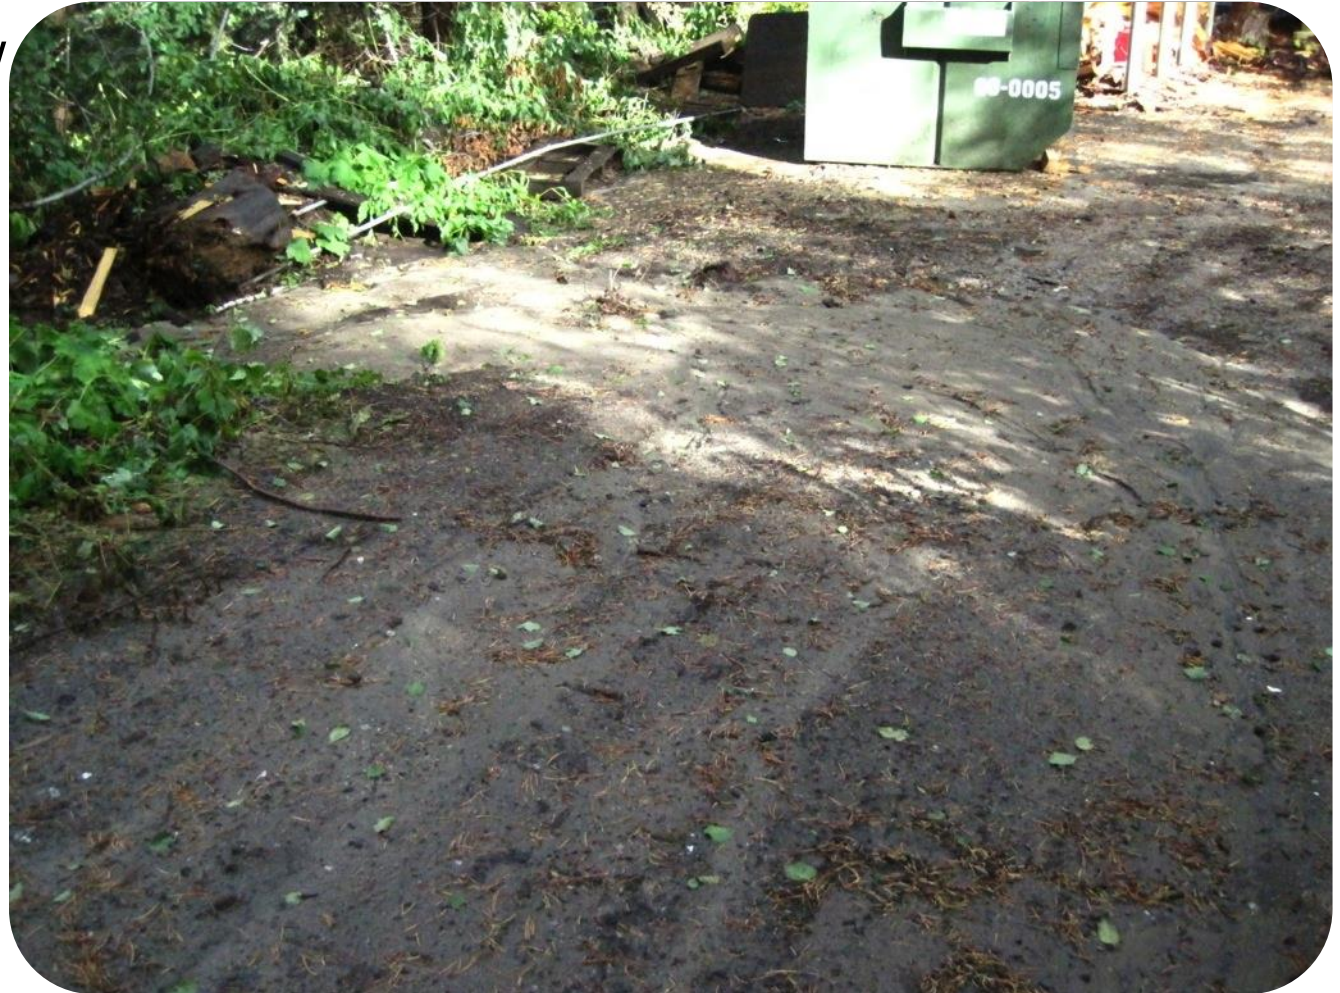
Erosion Problems

Sheet Flow

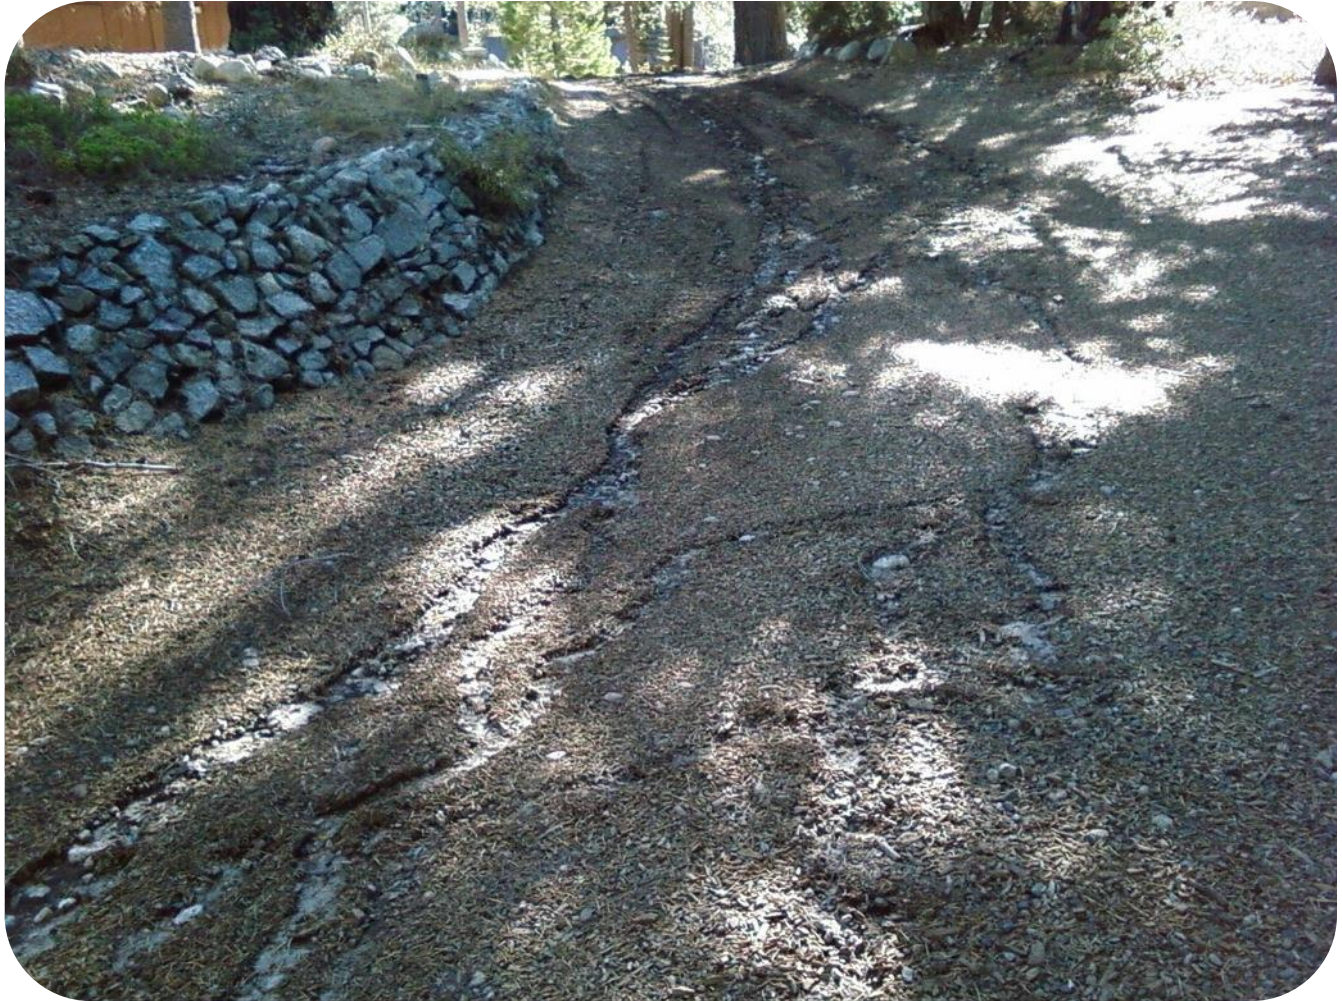
Facility Examples-Entry Road

Before

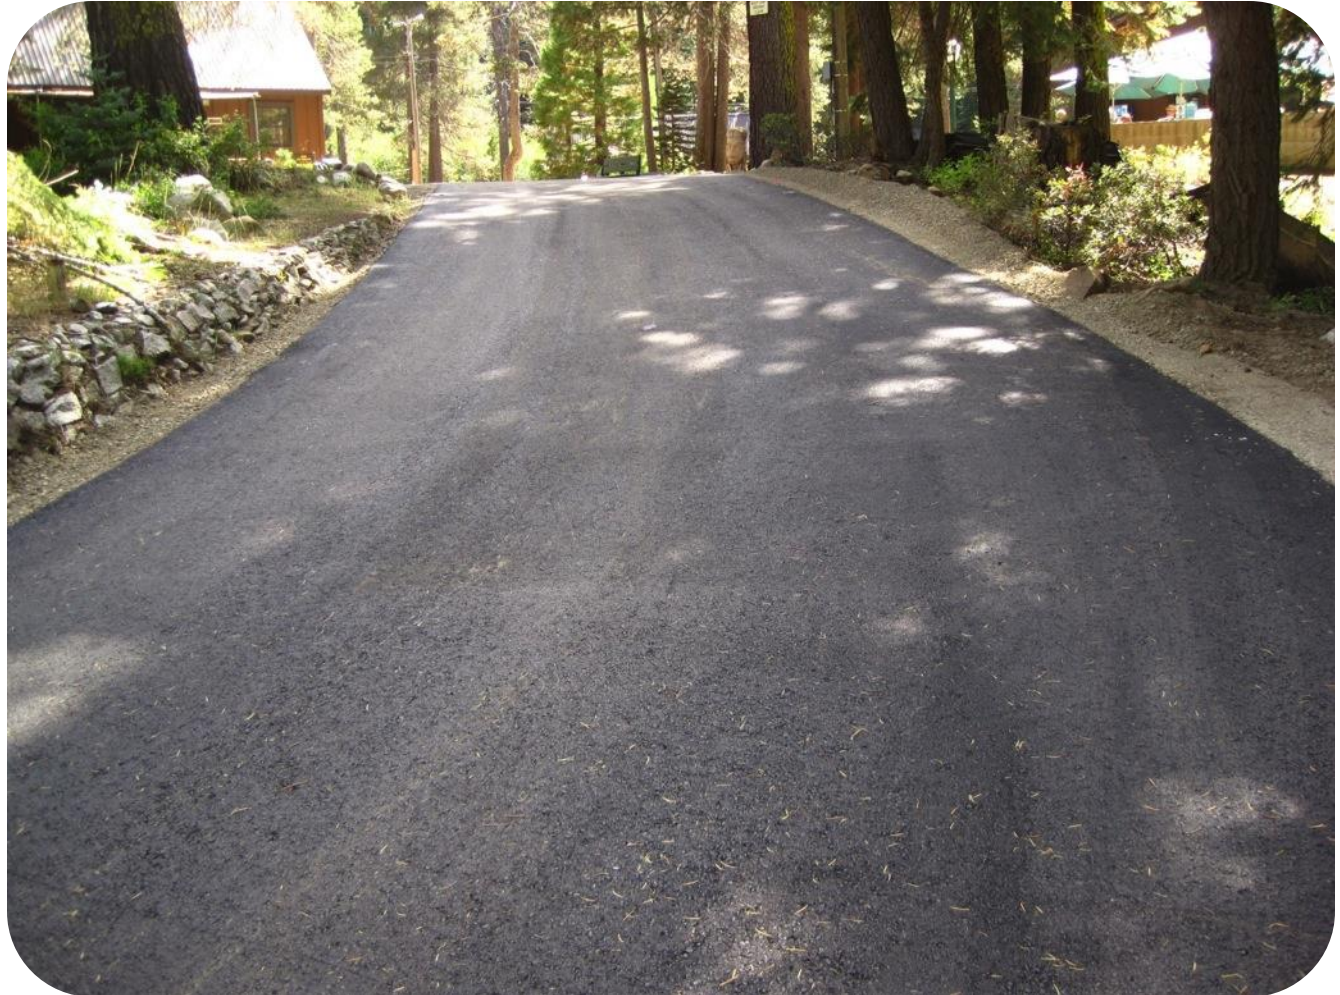
Facility Examples-Entry Road

After

- > Paved Entry Road from Bridge to Camp
- > Two Detention Basins to Receive Camp Runoff
- > Revegetation
- > Parking for Lover's Leap Trailhead

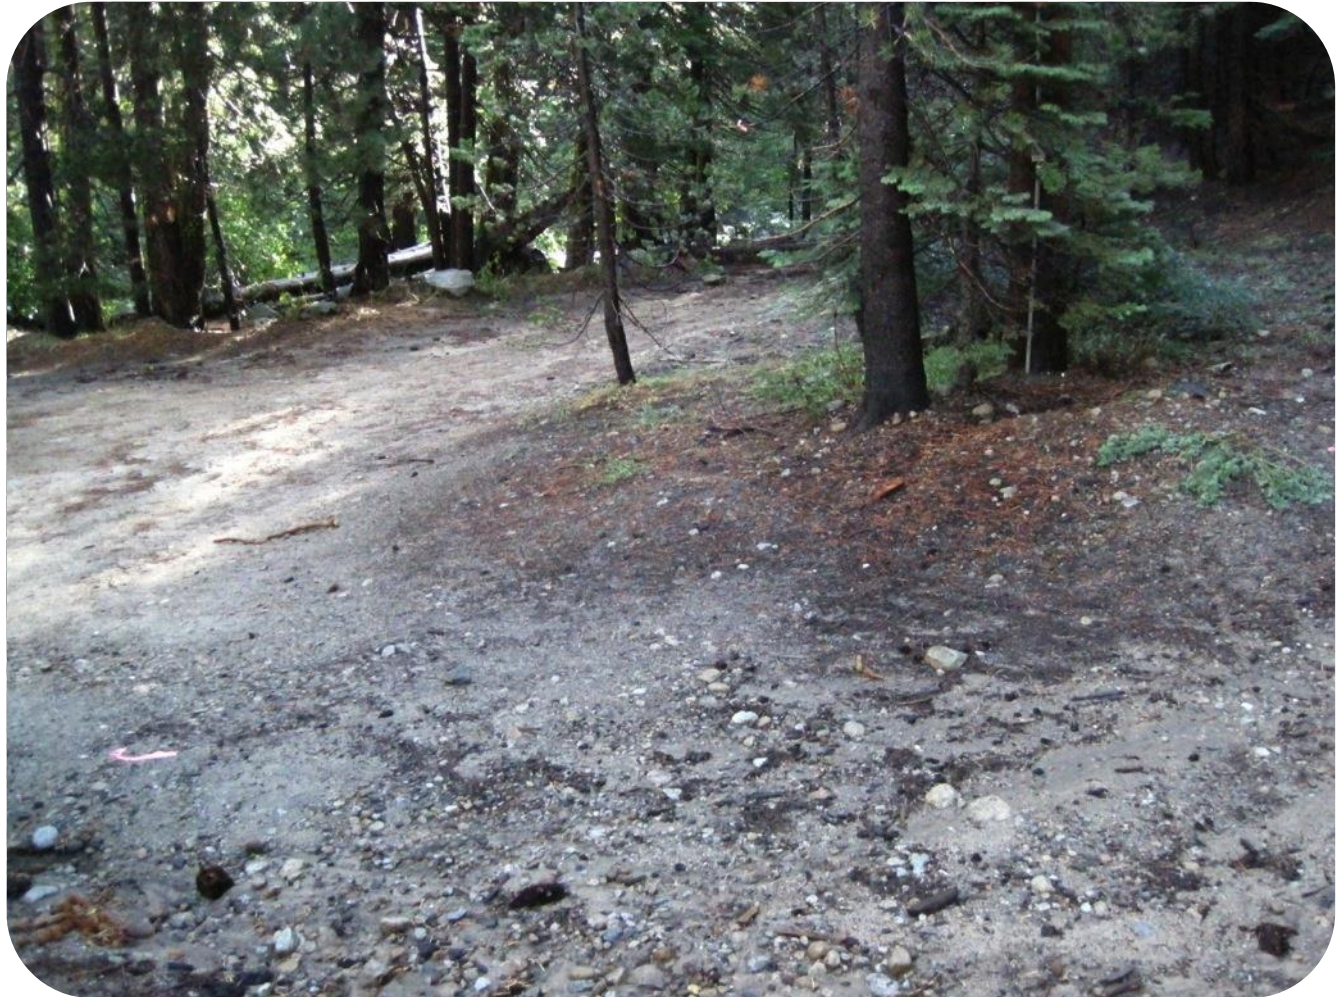
Facility Examples-Parking

Before

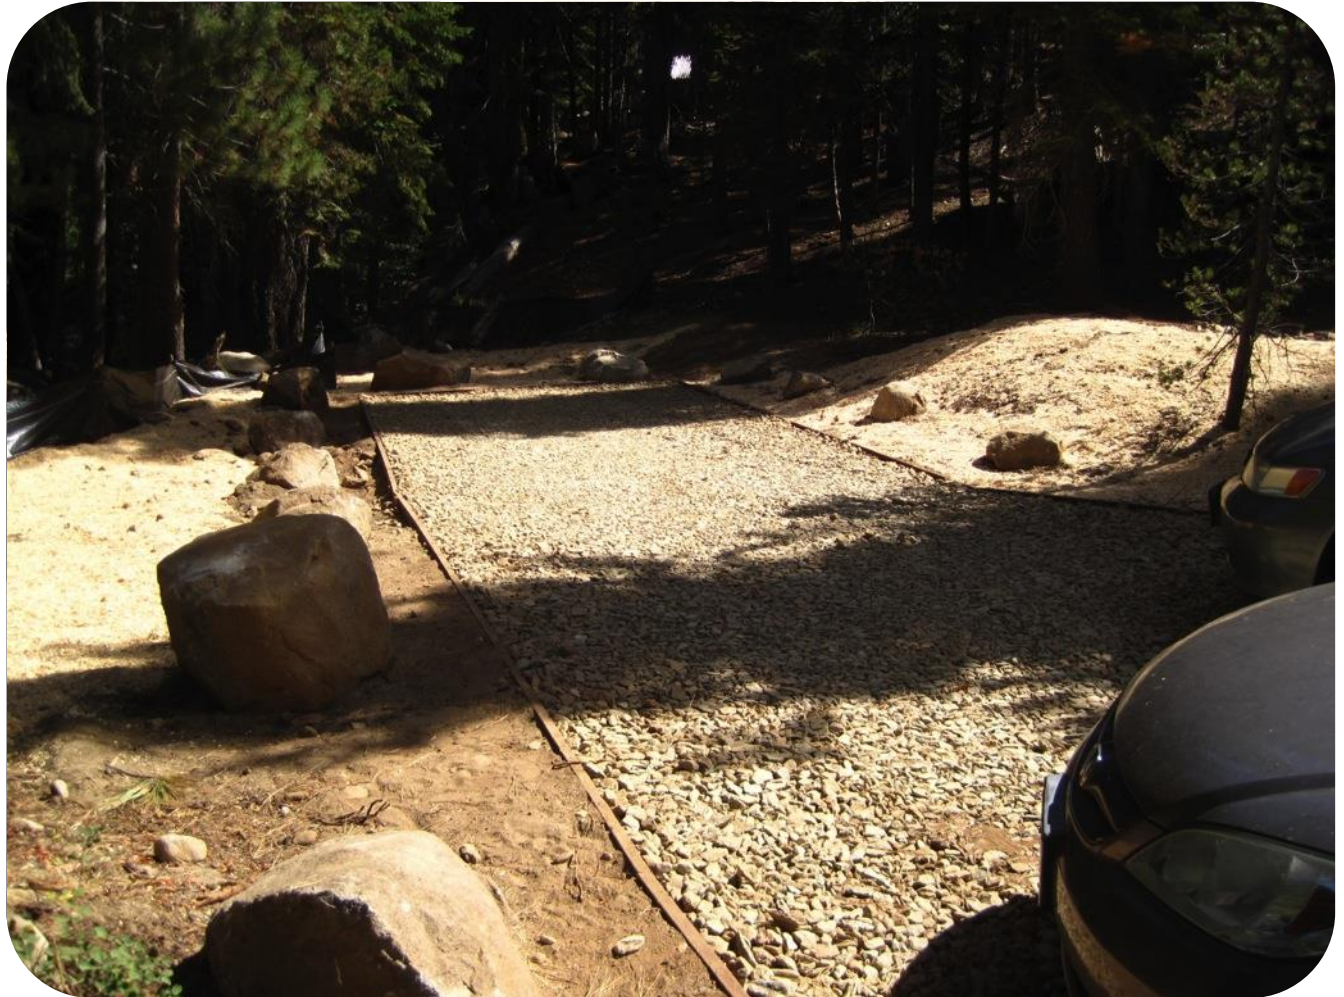
Facility Examples-Parking

After

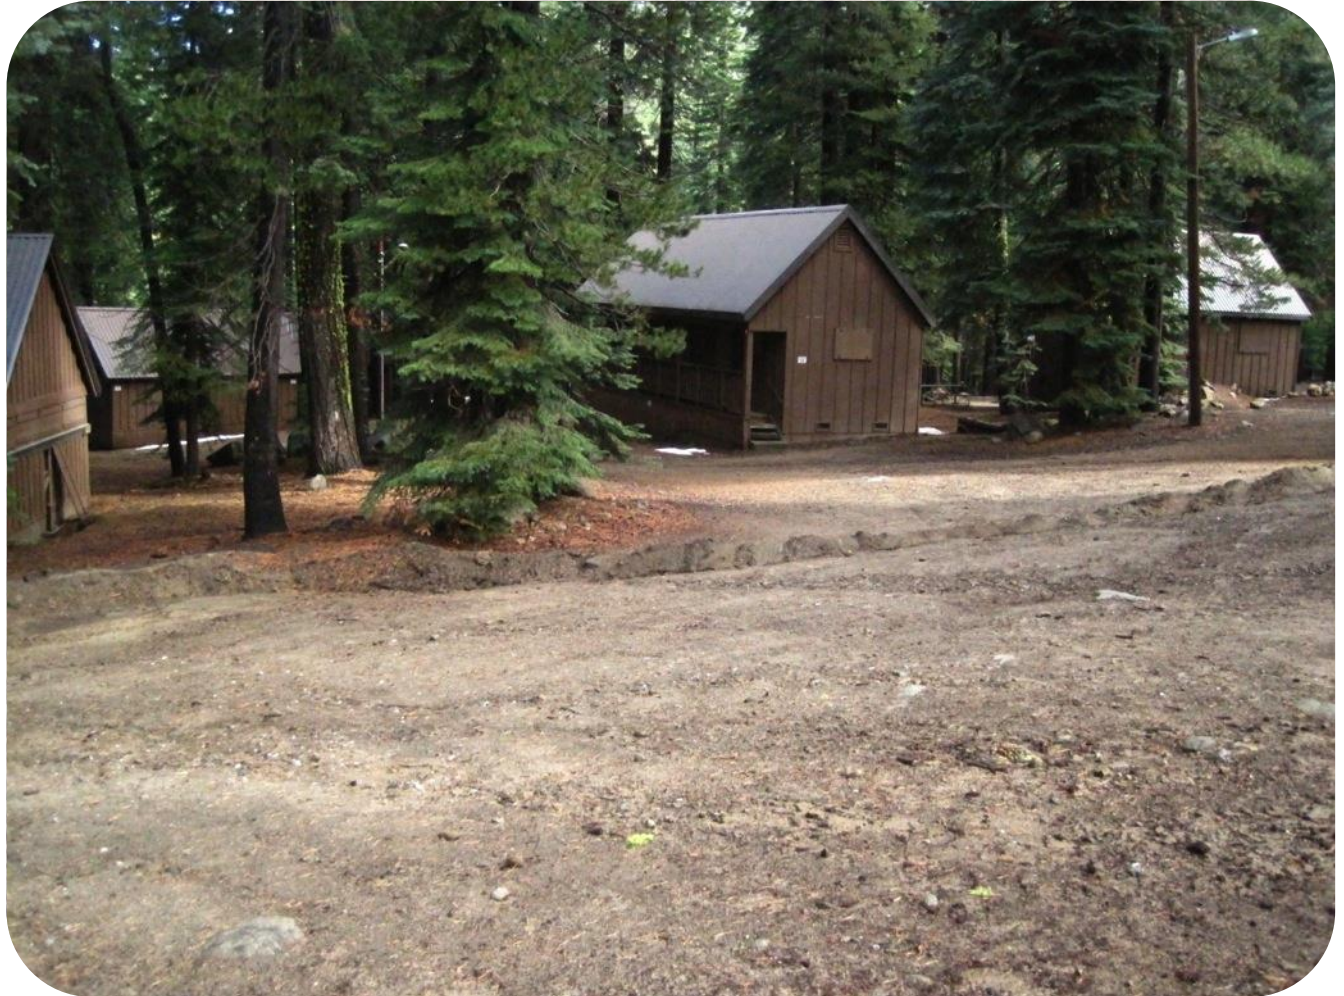
Facility Examples-Revegetation

Before

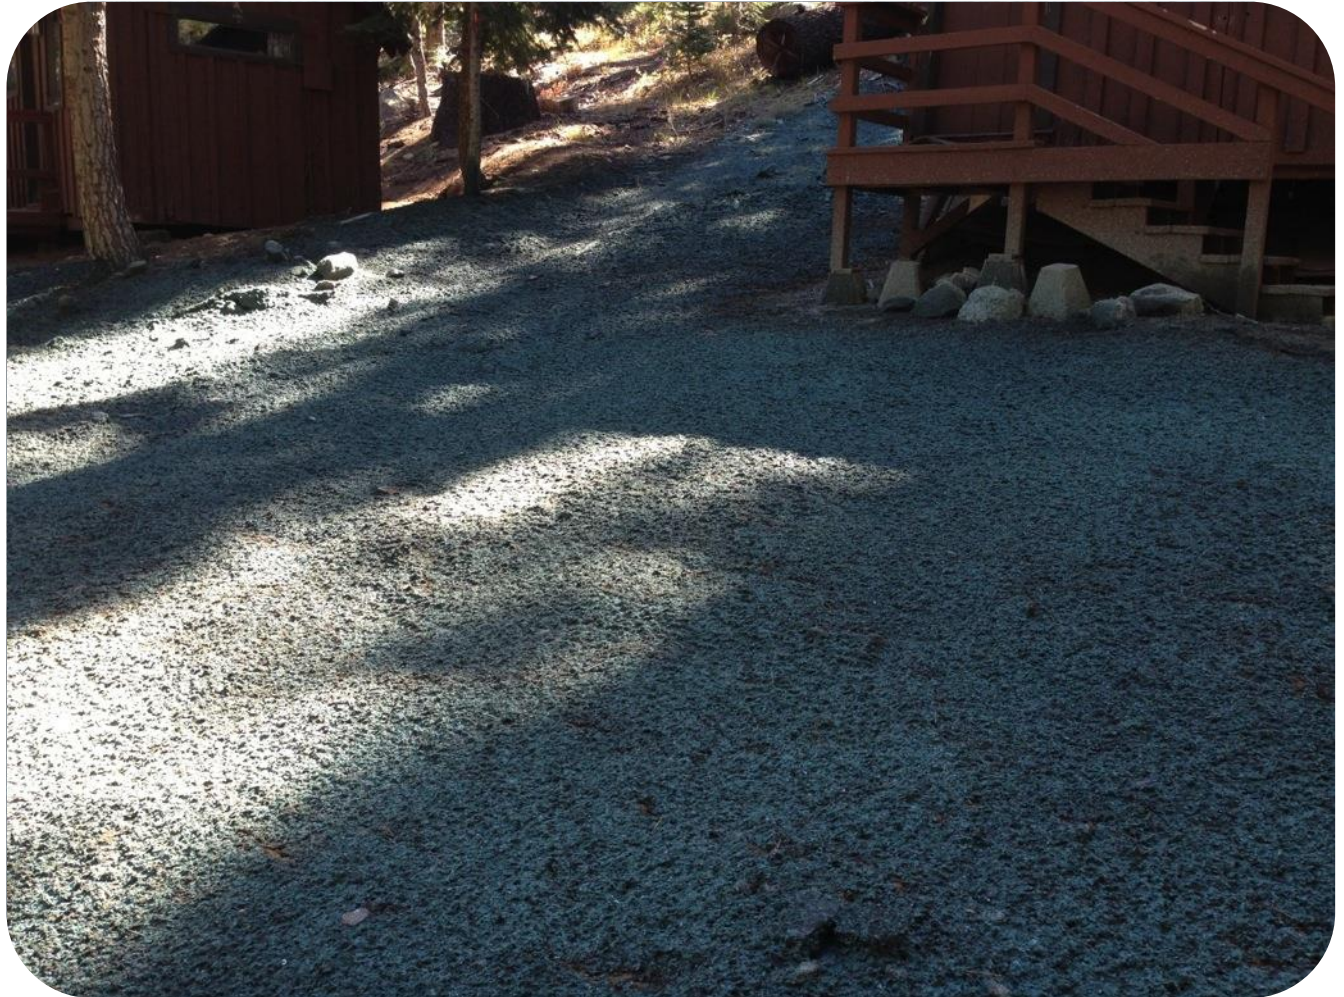
Facility Examples-Revegetation

After

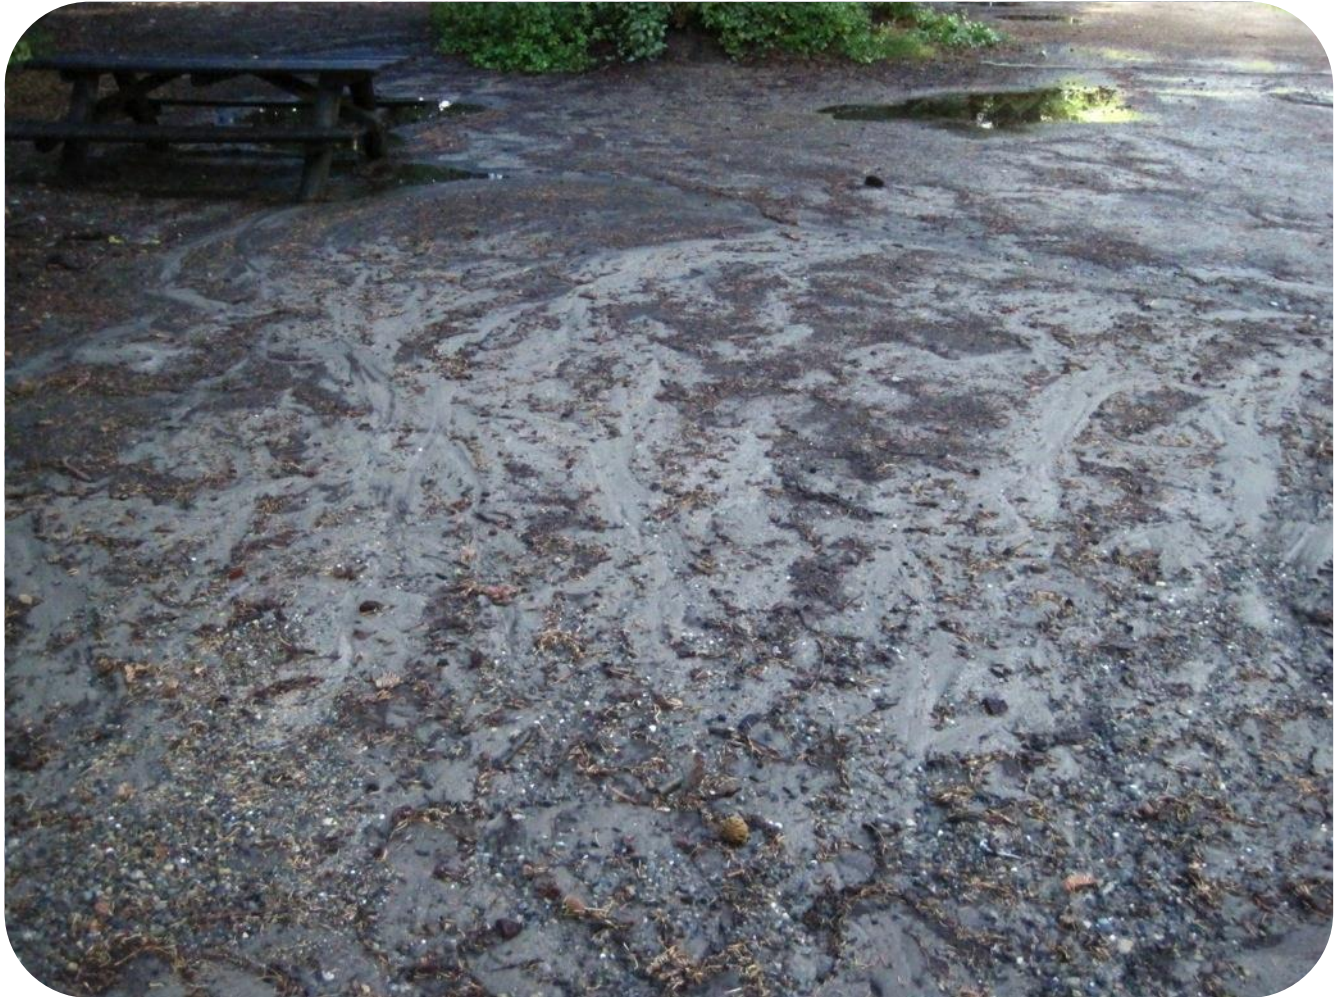
Facility Examples-Basin

Before

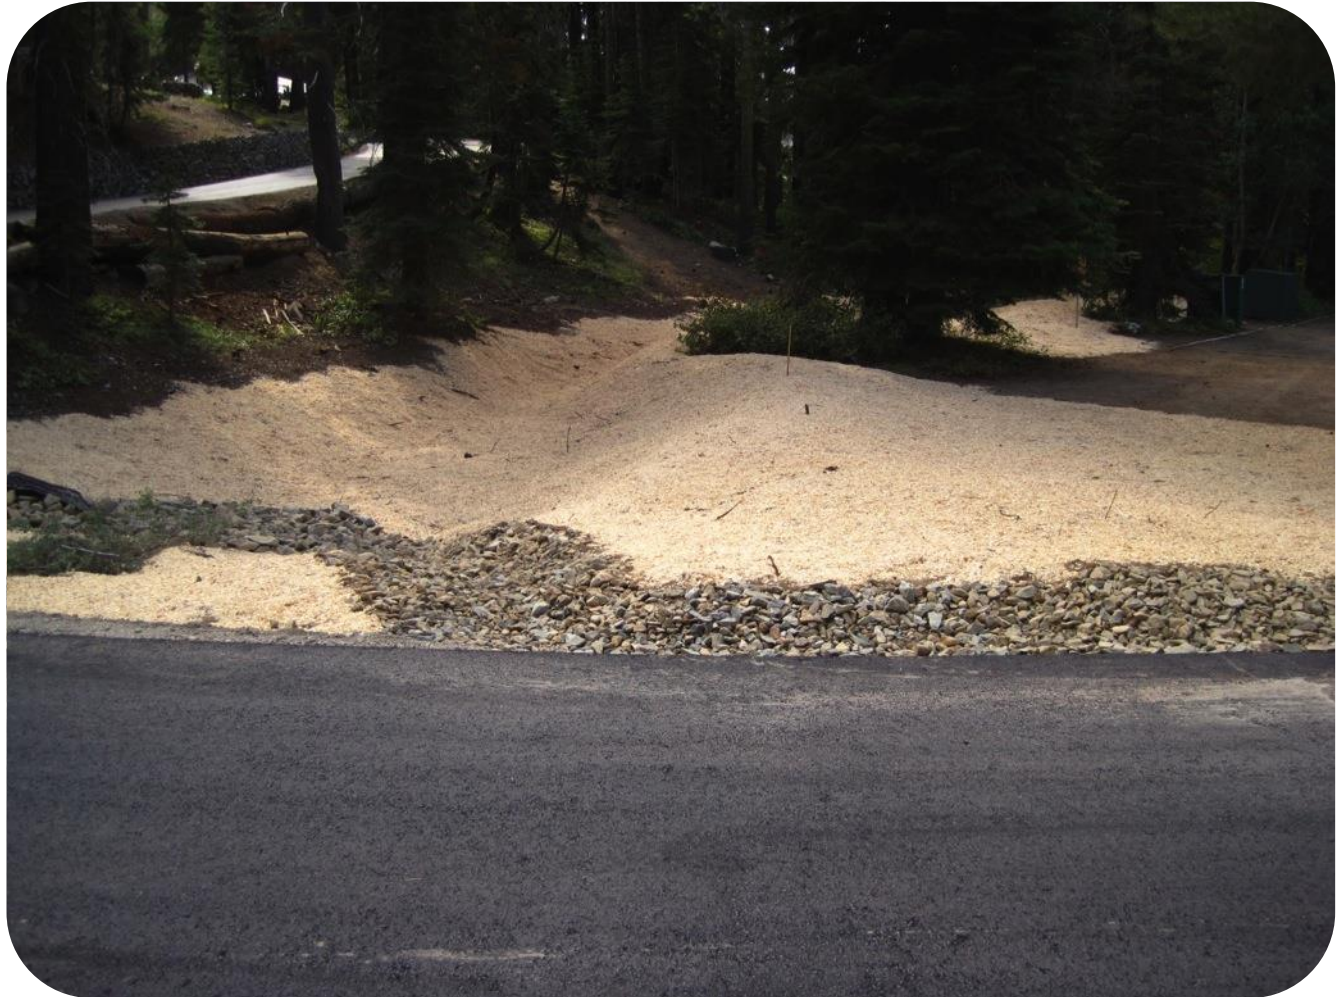
Facility Examples-Basin

After

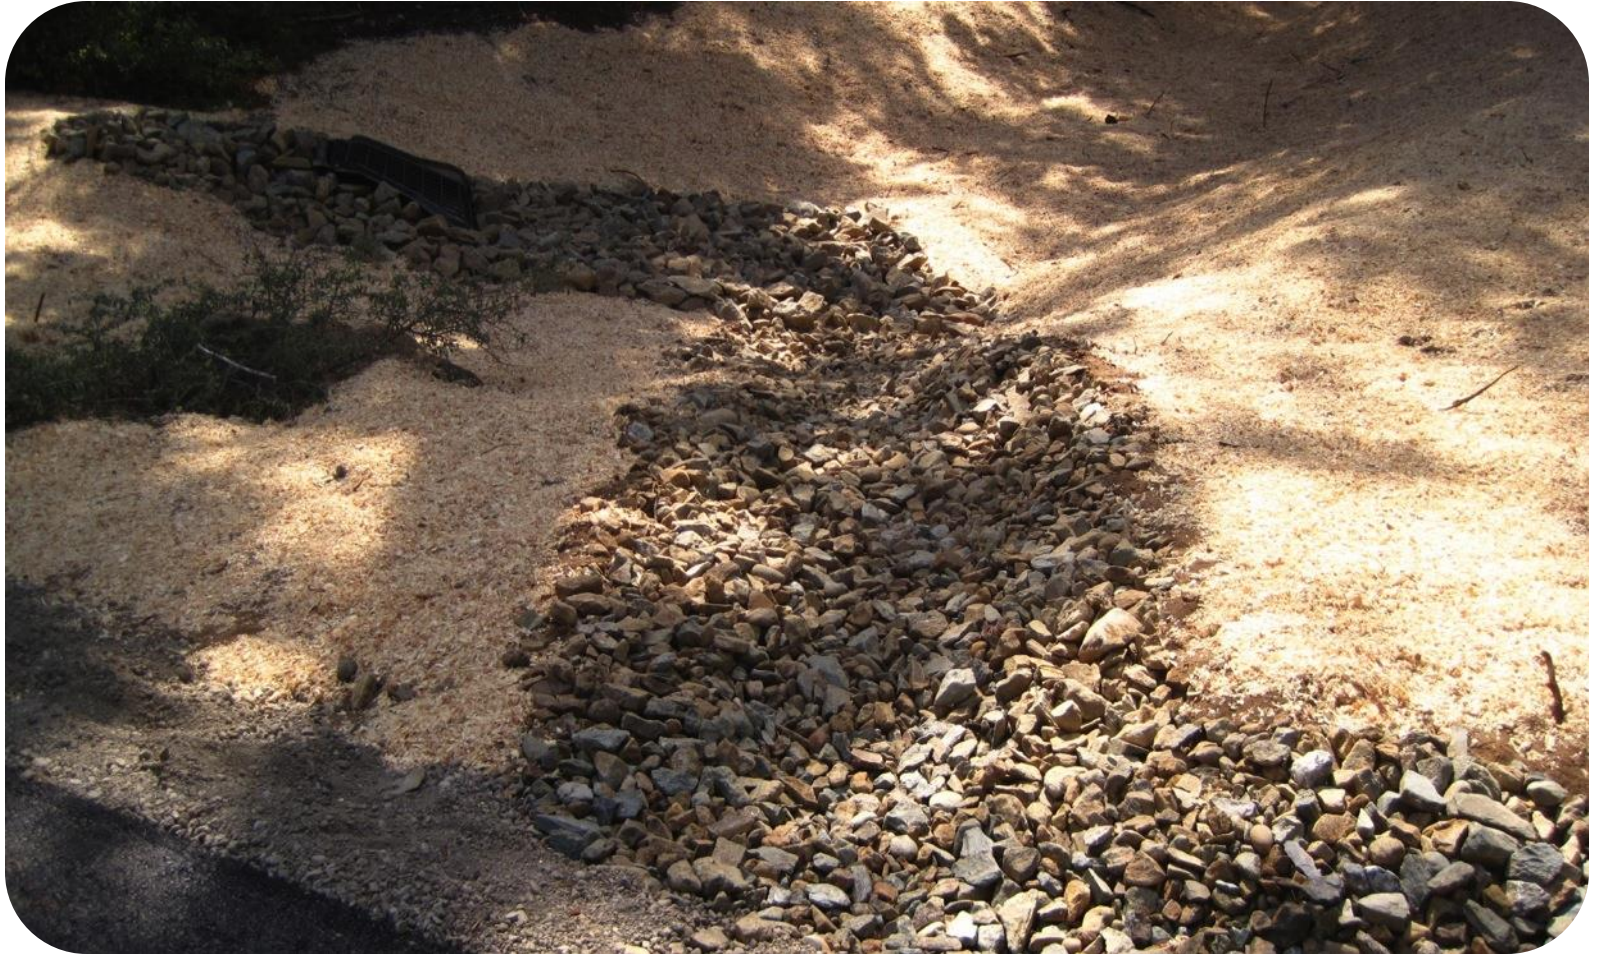
Facility Examples-Basin
