Erosion Control in Mountain Recreation Areas

Paul Wisheropp, P.E. CFM
Cardno ENTRIX

Camp Sacramento Erosion Control and Habitat Restoration Project

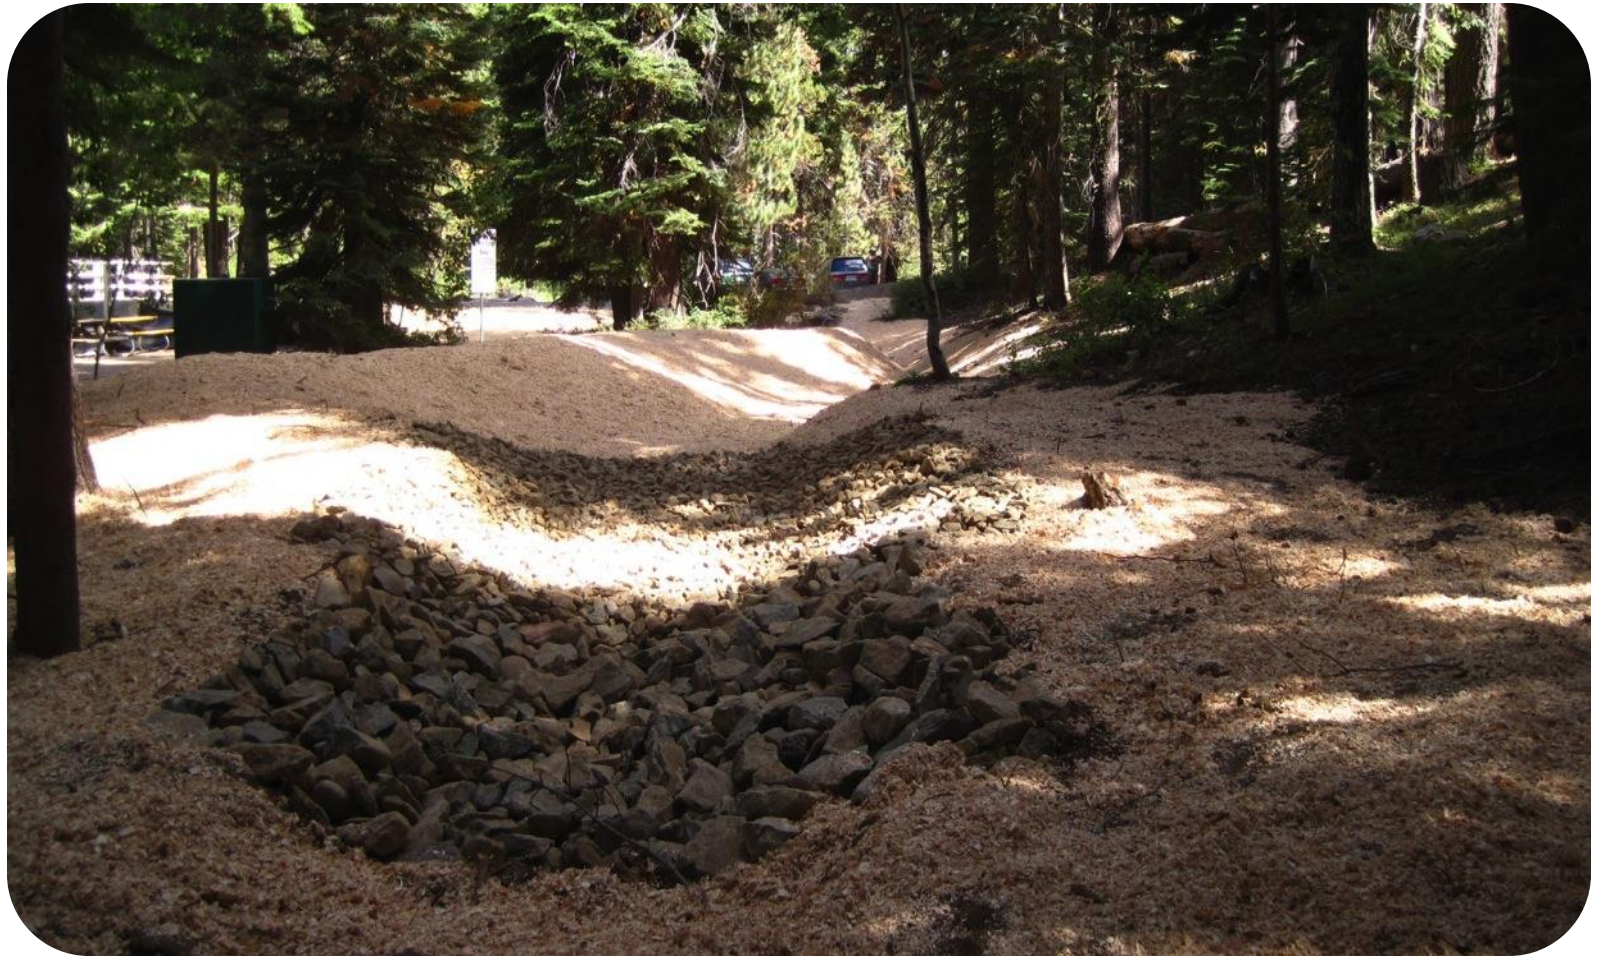
Facility Examples-Basin

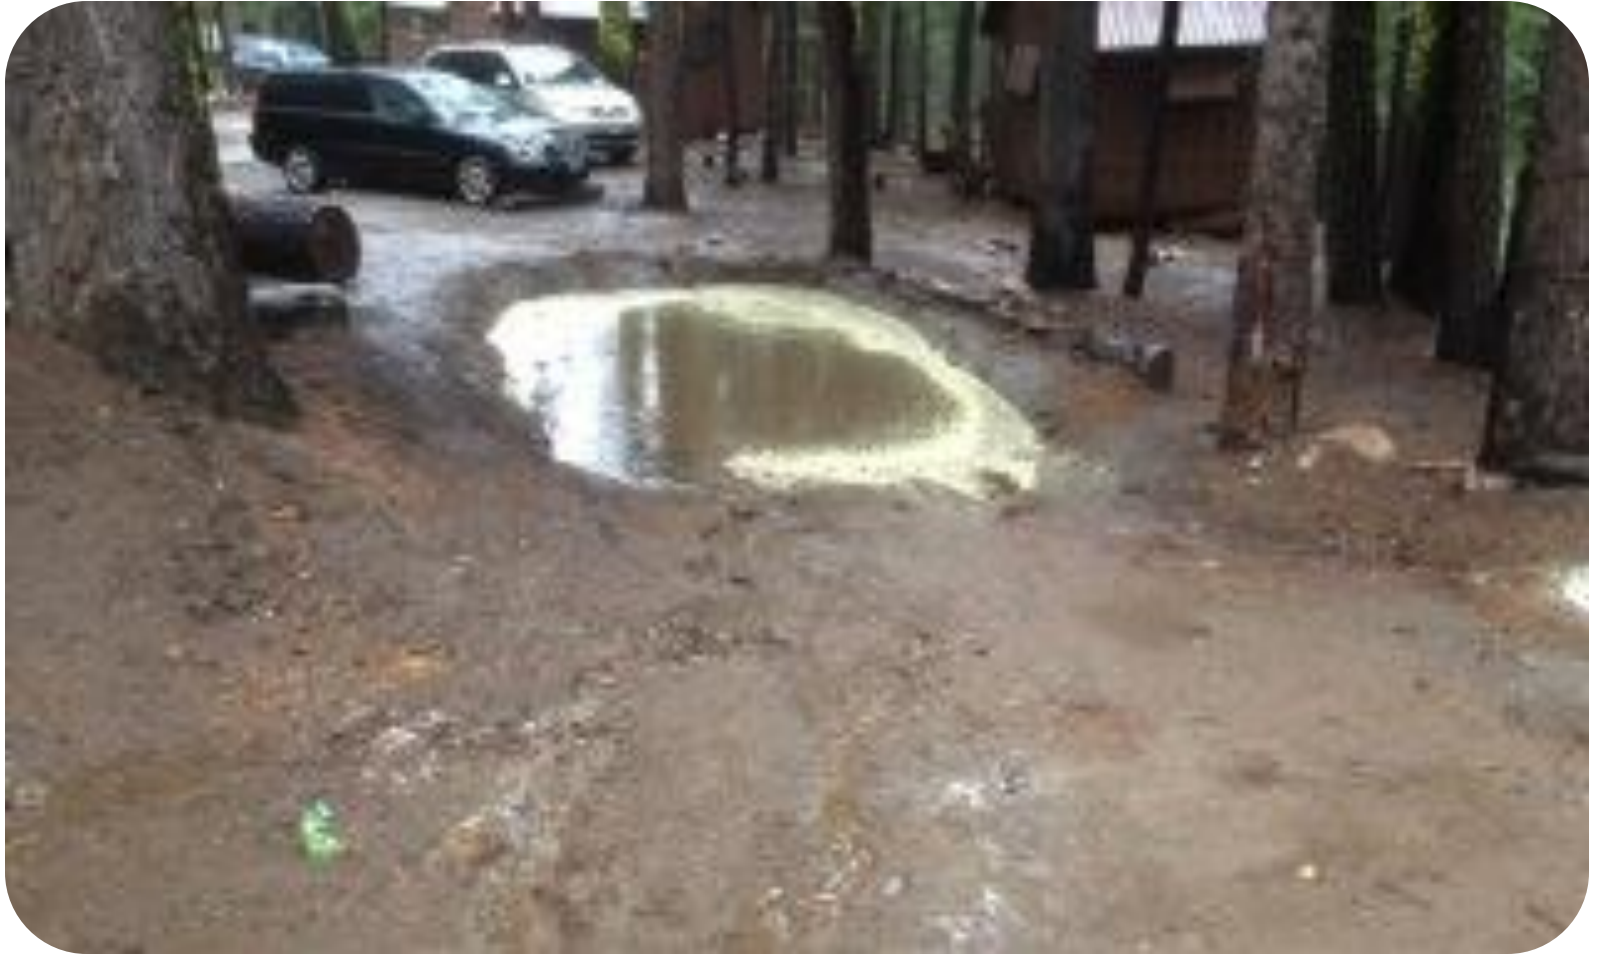
Temporary Measures

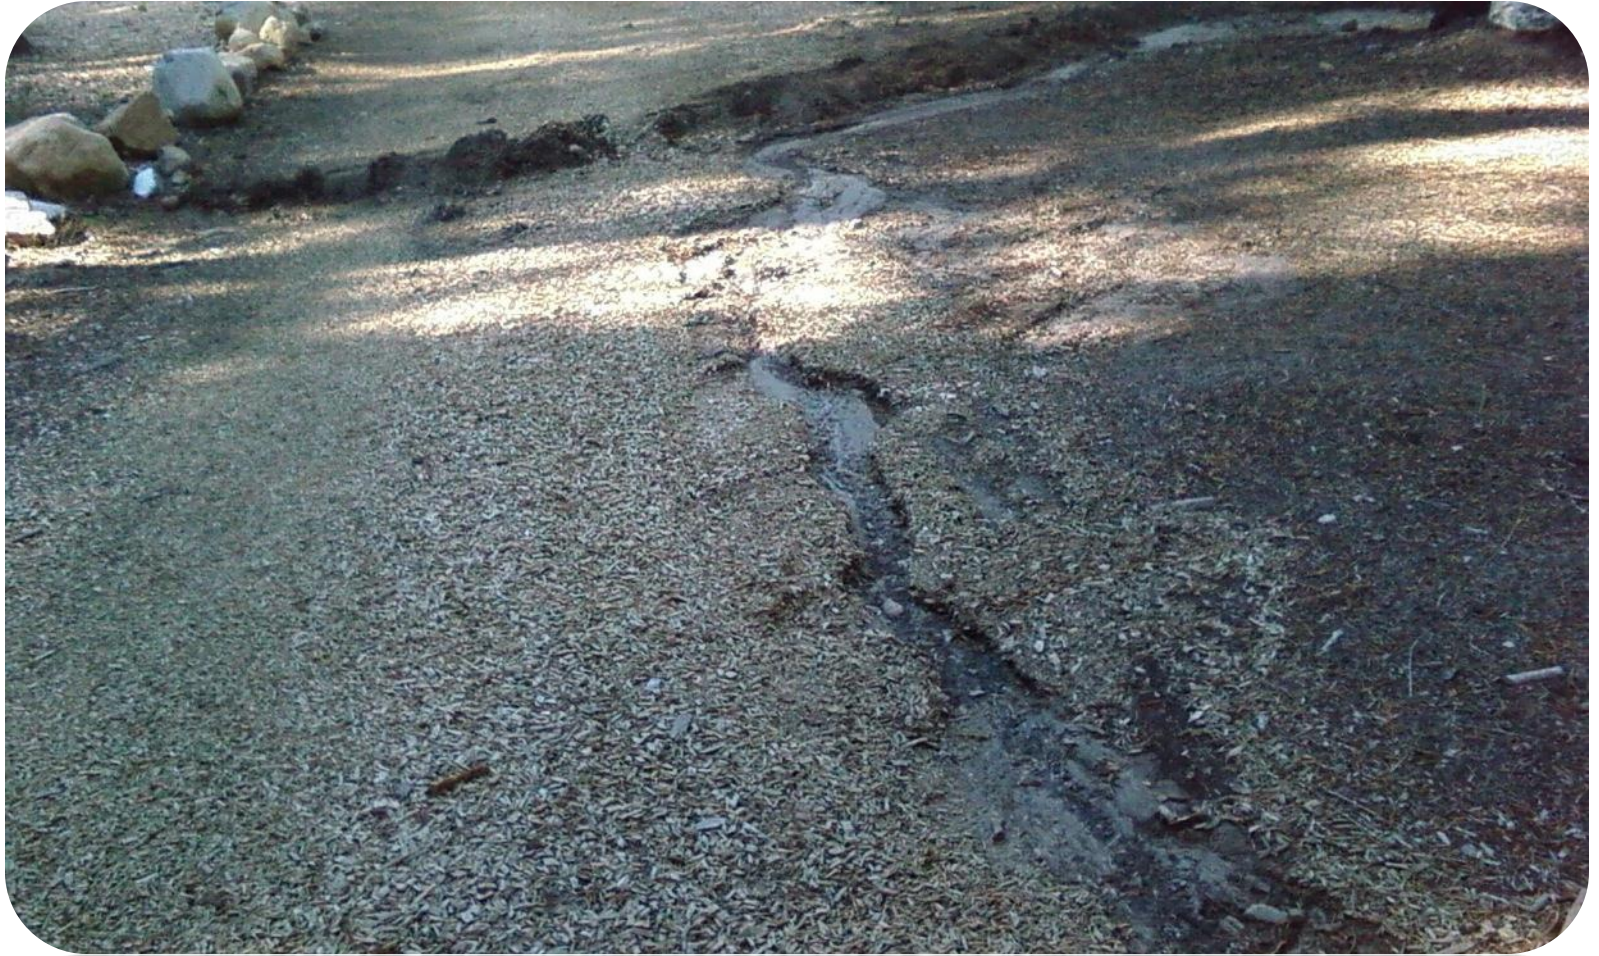
Temporary Measures

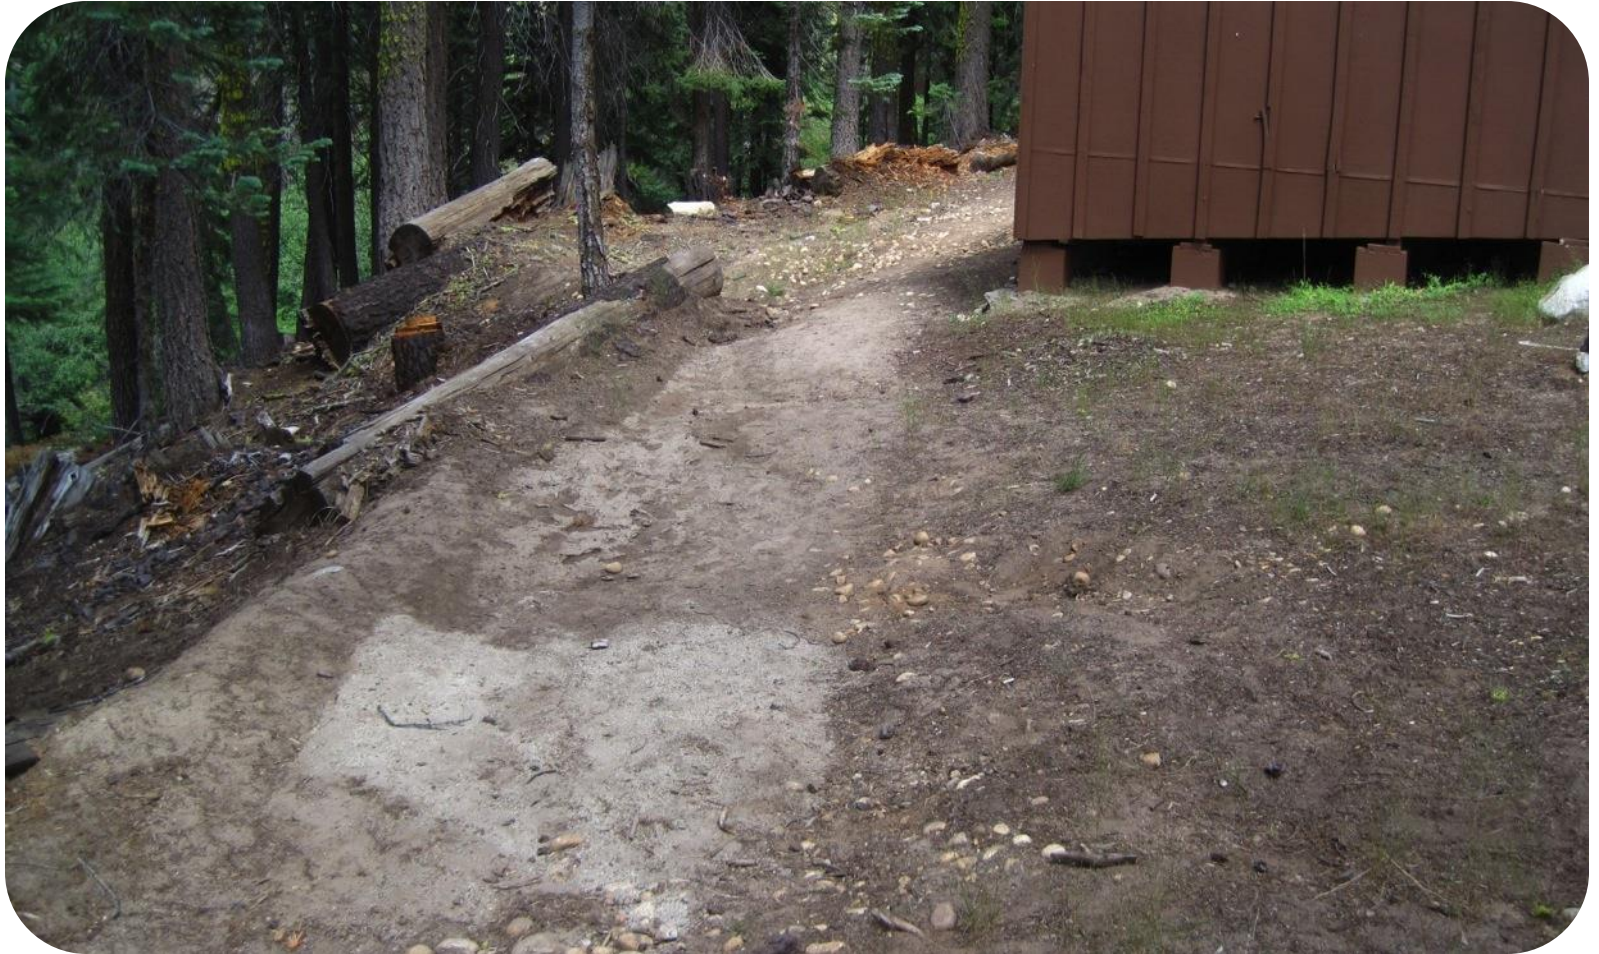
Temporary Measures
