Unmanned Aircraft Systems (UAS) Capabilities and Expertise

Applications of UAS in the Water Resource Industry

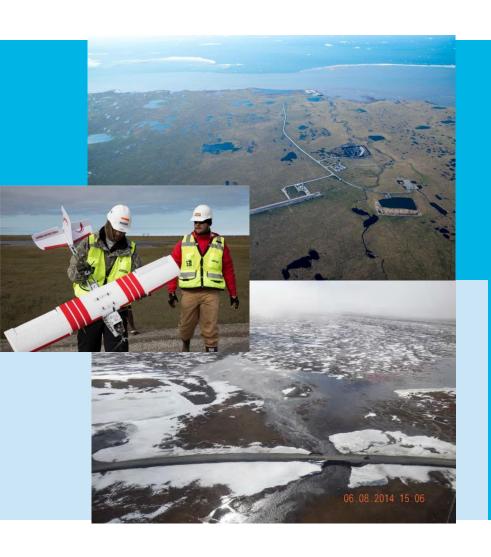
Environmental Support on Alaska's North Slope 2015

AECOM conducted an Analysis of Alternatives (AoA) and UAS Aerial Survey on the Alaska North Slope for Exxon Mobil:

- Imaged tundra vegetation and hydrology conditions for XOM environmental assessment requirements
- Employed two types of UAS (quadcopter and fixed wing) in a harsh environment
- Flew multiple flights from airstrip and roads over tundra with no-tundra encroachment
- Flew 60 hours, provided extensive high fidelity still photo and video imagery

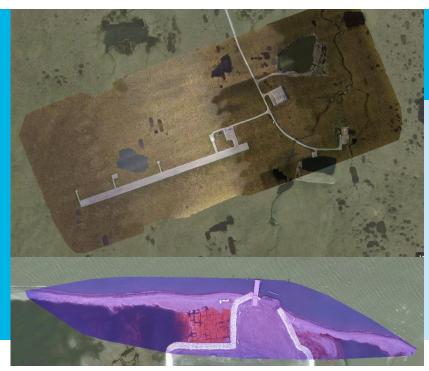
Shoreline Multispectral Mosaic

- Shoreline erosion assessment collected and mosaicked 6 miles of multispectral (BGNIR) imagery and 1 mile of high fidelity photo (RGB) imagery of the Alaska North Slope shoreline.
 - Operated BVLOS on portions of multiple flights
- Tundra hydrology and vegetation monitoring -BGNIR and RGB imagery of the airfield and surrounding area and river crossing sites
- Pipeline Vertical Support Member (VSM)
 assessments videoed three VSMs recently
 installed at pipeline sag points.
- Mine site monitoring extremely high fidelity NIR imagery (50' AGL)
- Flew 49 Quadcopter SUAS flights in harsh conditions

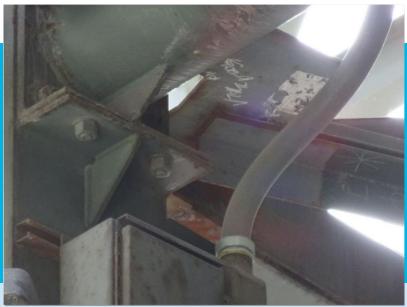
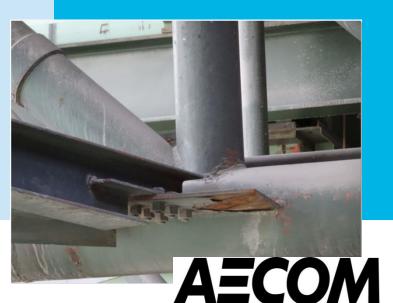
APS Power Station 4 Corners NM

- AECOM conducted UAS inspection of structural steel members supporting SCR ducts.
- Inspection focused on identifying rust and missing hardware. Employed small DJI Inspire UAS to fly in and amongst the steel in a non–GPS supported environment, to capture desired high resolution imagery.
- Required close, controlled, manual flight profiles to capture required imagery

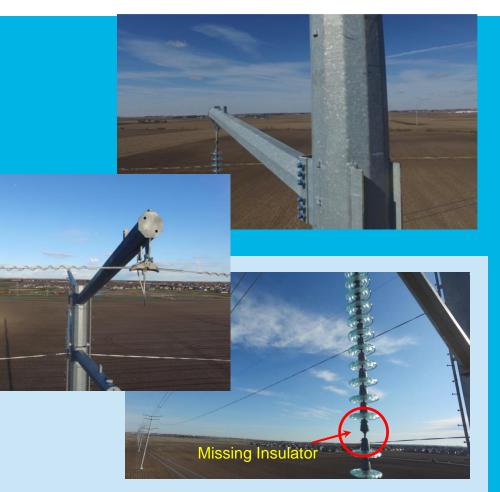
Ameren Transmission Tower UAS Inspection

- AECOM conducted UAS inspection of 165
 power transmission towers along a 30 mile
 corridor near Champaign, IL. Documented
 critical connection points, grounding straps,
 insulators etc. Employed small DJI Inspire
 UAS to fly in and amongst the towers and
 powerlines to capture desired high
 resolution still imagery.
- Every tower along the corridor was imaged providing an accurate condition/status and historical documentation prior to the entire line being entered into service and powered on by customer.
- Required close, controlled, manual flight profiles to capture required imagery

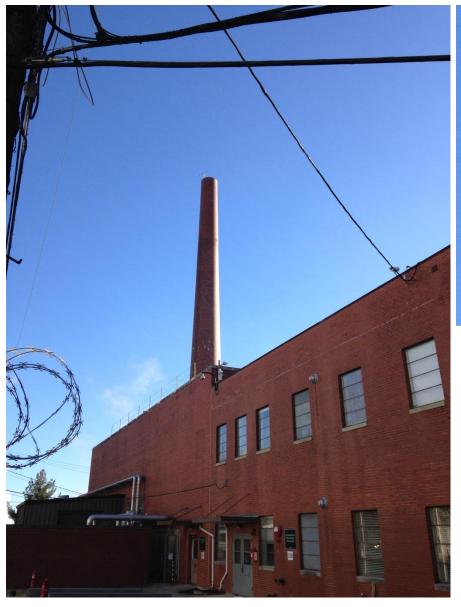
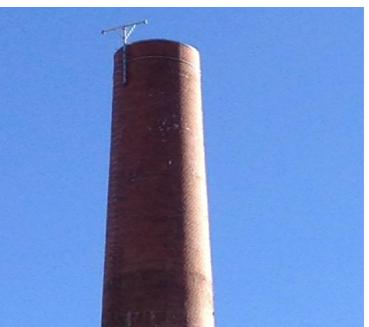
Industrial Stack Inspection: External and Internal

- AECOM created UAS solution to inspect the interior of the chimney safely and cost effectively while reducing the inspection time from days to hours and achieving higher level of detail
- 1 of 3 ---250' Chimney—requires periodic internal inspection to determine integrity.
- Traditional method requires a crane to lower an inspector into the chimney resulting in costly/lengthy shutdowns, safety concerns
- Using UAS Stack Shutdown to Inspection Completion was just over 1 hour

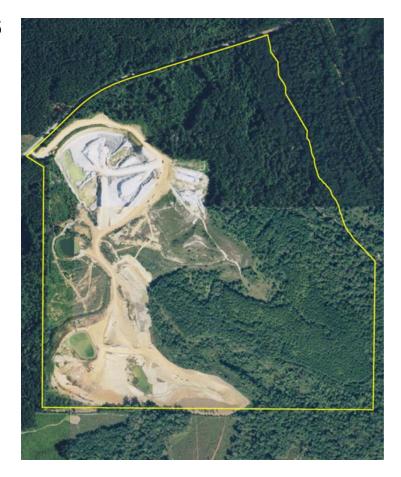
Aerial Imagery and Mapping

- Provided aerial imagery of mine site for environmental reclaiming required inspections.
 - Imagery provided geo-rectified, decision quality information and aerial mapping to support:
 - 3-D Terrain Modelling (DTM)
 - Volumetric calculation
 - Inspection measurements
 - Silt fence placement and condition
 - Vegetation
 - Erosion
 - Contour map
- Provided aerial imagery of potash stock pile and reclaimed waste area.
 - Imagery provided geo-rectified, decision quality information and aerial mapping to support:
 - 3-D Terrain Modelling (DTM)
 - Volumetric calculation
 - 2 day event operating UAS quadcopter
 - Successfully de-conflicted airspace and gained Government approvals
 - Demonstrated safe and effective UAS aerial survey operations

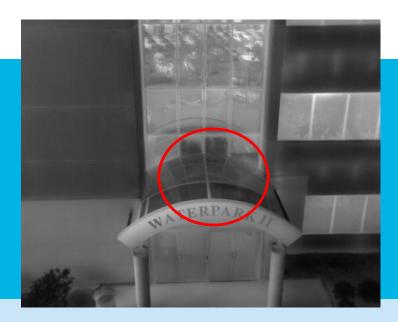
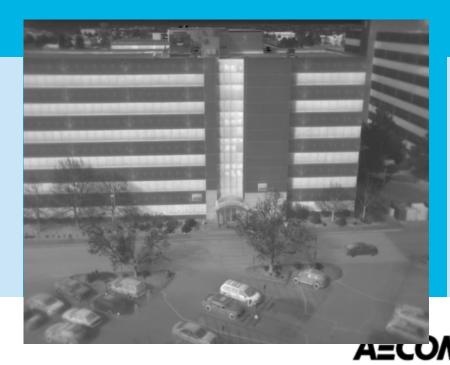
Thermal Building Inspection

- 2 Office complex's reporting water entering the building. Roof tops Mapped with traditional RGB camera and with FLIR XT camera.
- Building fronts scanned and video documented of the facades and rooftops.
